**JOINT USER COMPLEX AND
WHOLESALE FISH MARKET AT
AREA 44, TUEN MUN**

**FOURTH QUARTERLY
ENVIRONMENTAL MONITORING &
AUDIT REPORT
(MAY 2009 – JULY 2009)**

ALLIED ENVIRONMENTAL CONSULTANTS LTD.

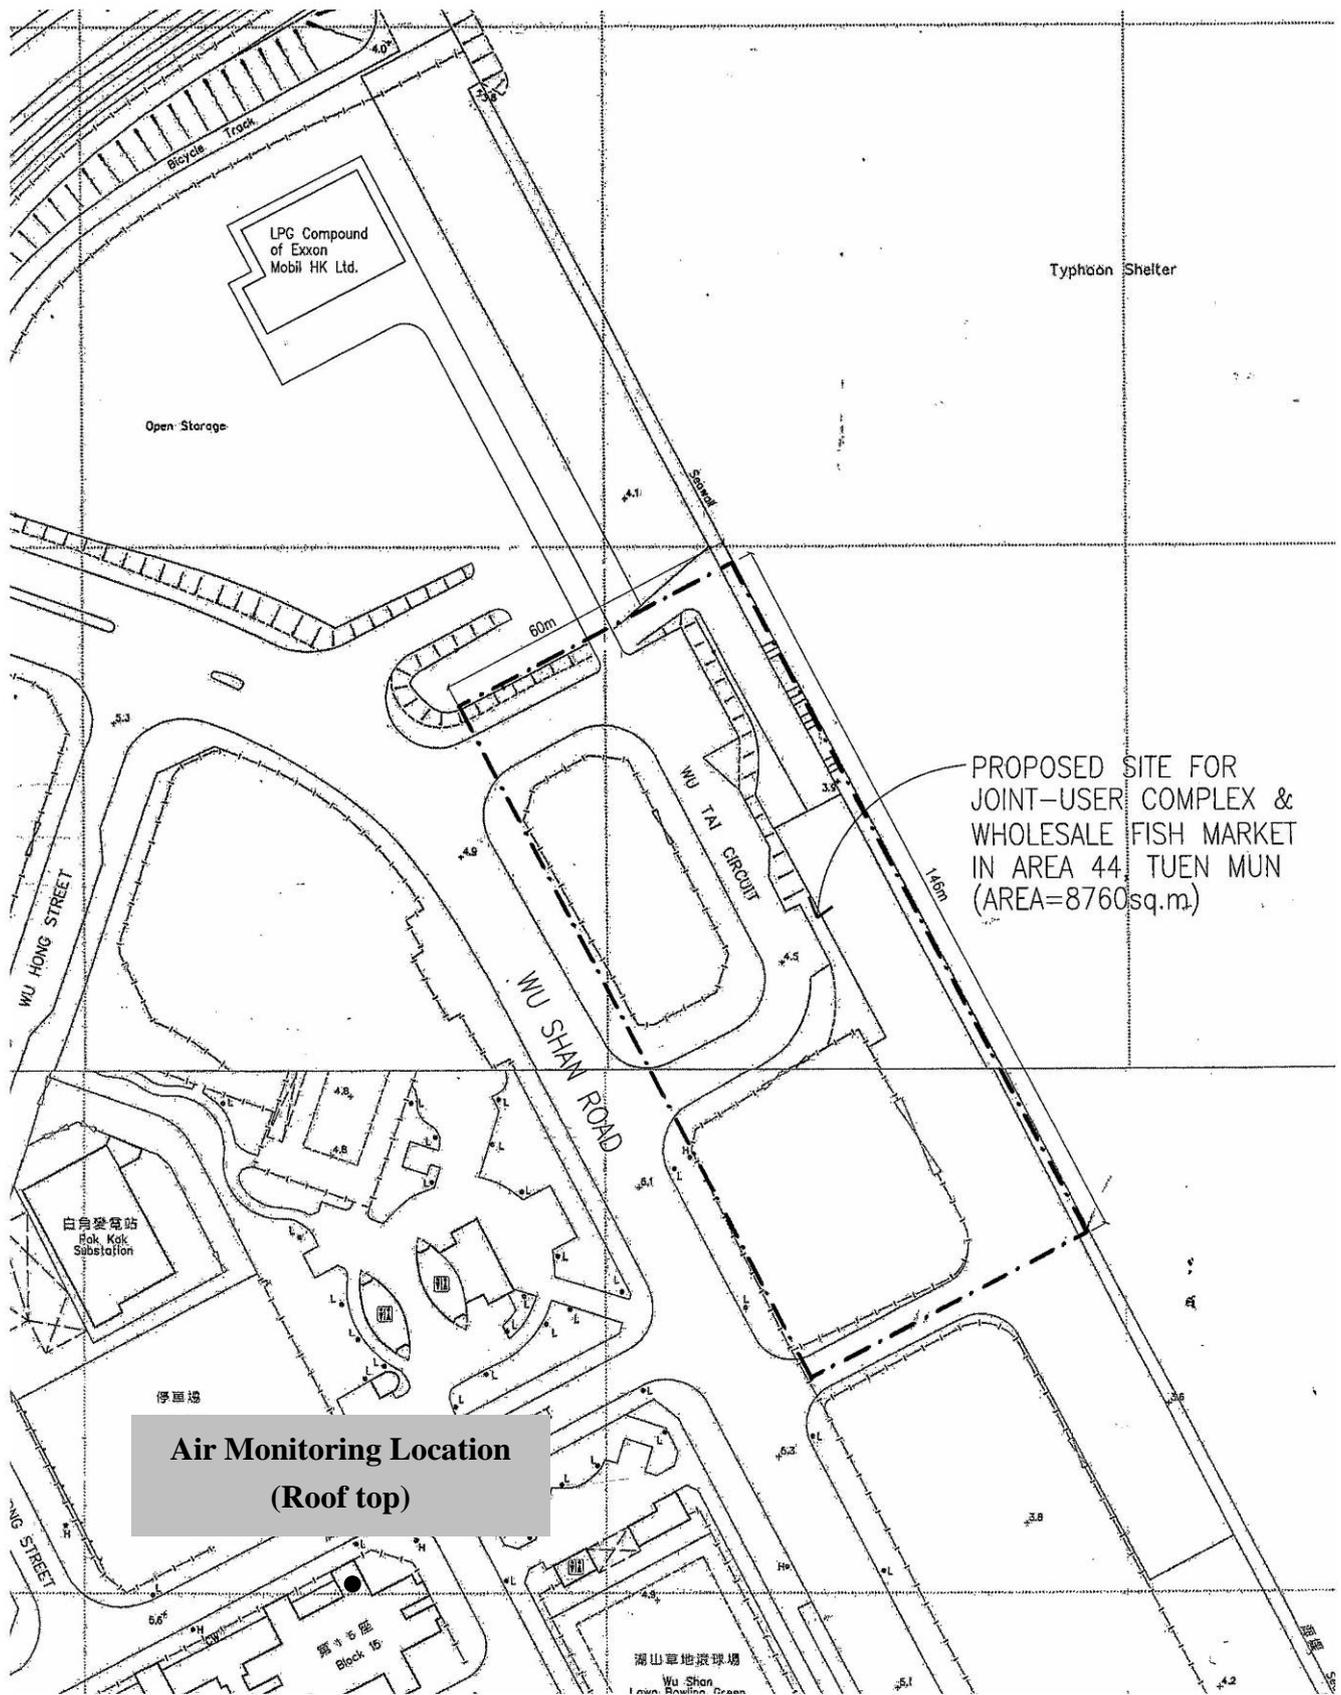
Figure No.	Rev.:
2	0
Scale	Date
NTS	9/09

Air quality monitoring and noise monitoring were conducted at Block 15, Yuet Wu Villa on 4th, 9th, 15th, 21st and 27th May, 2nd, 8th, 13th, 19th and 25th June, 2nd, 8th, 14th, 20th, 25th and 31st July 2009. Appendix A displayed the detail schedule of the monitoring programme. Air quality monitoring station was set up at the roof top of the residential block and noise monitoring was conducted at 1.2m above ground level in front of the residential block and at the junction of Wu Sau Street and Wu On Street as given in Figure 2 and 3. Figure 4 and 5 show photos taken during monitoring at the two locations.

LOCATION OF AIR QUALITY MONITORING STATION

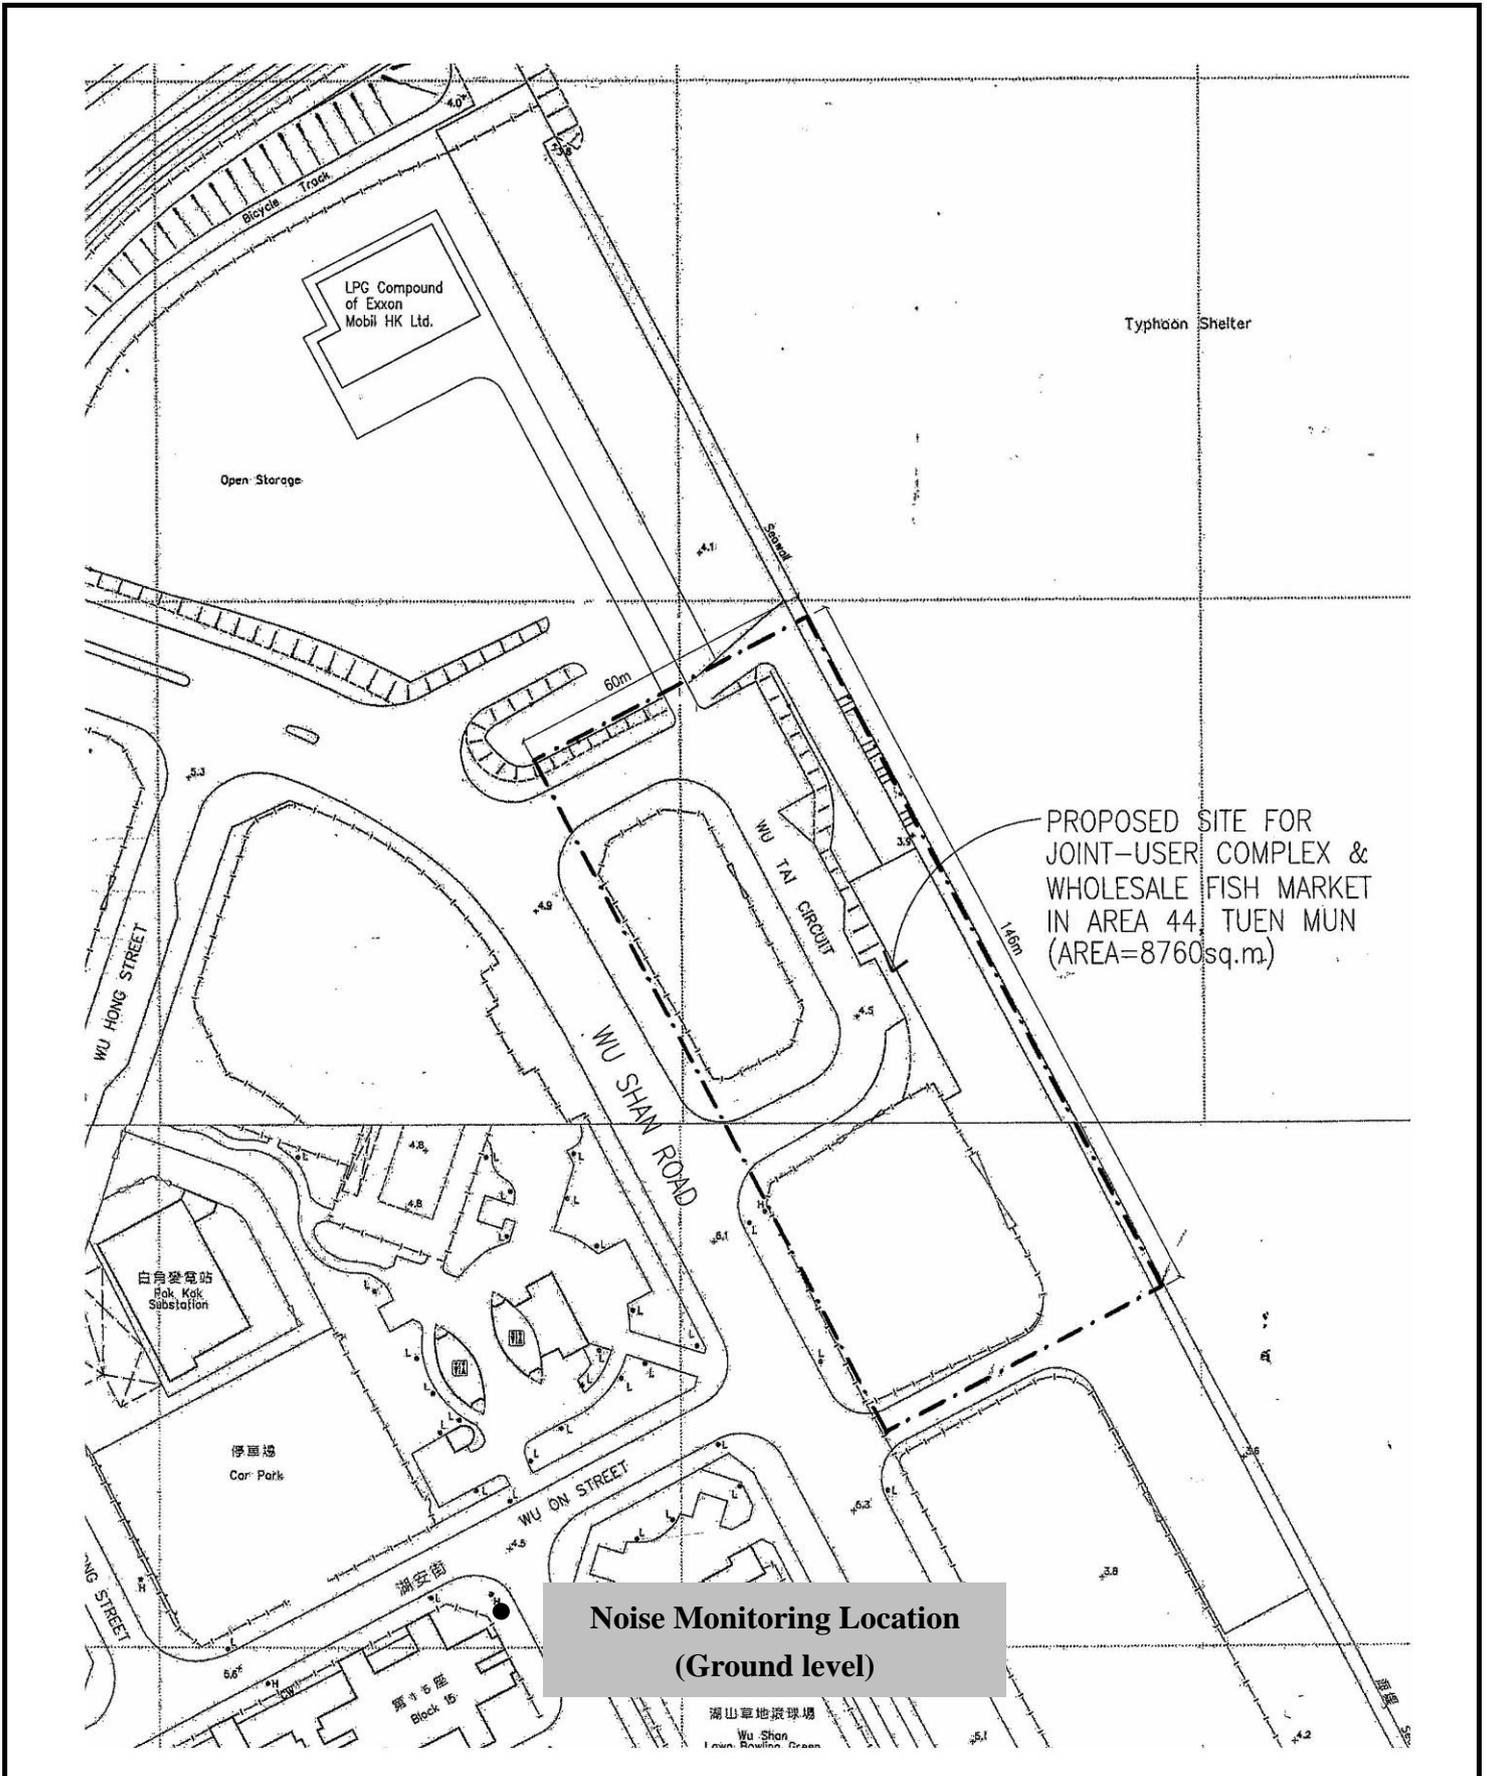
Figure No.	3	Rev.:	0
Scale	NTS	Date	9/09

Noise levels measurements were recorded in terms of thirty minutes A-weighted equivalent continuous sound pressure level ($L_{eq}(30min)$) on a weekly basis. The sound level meter was calibrated immediately prior to and following each noise measurement. The meter was mounted on a tripod at a height of 1.2m and the microphone was positioned at 1m away the building façade of the noise monitoring station facing the construction site.

**JOINT USER COMPLEX AND WHOLESALE FISH MARKET AT AREA 44,
TUEN MUN
LOCATION OF NOISE MONITORING STATION**

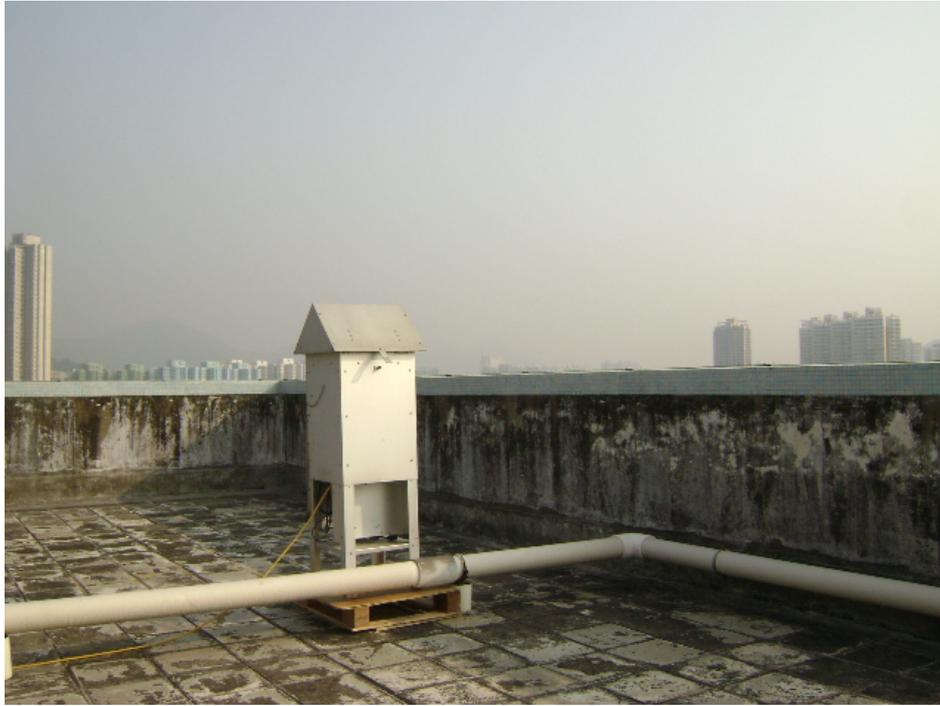
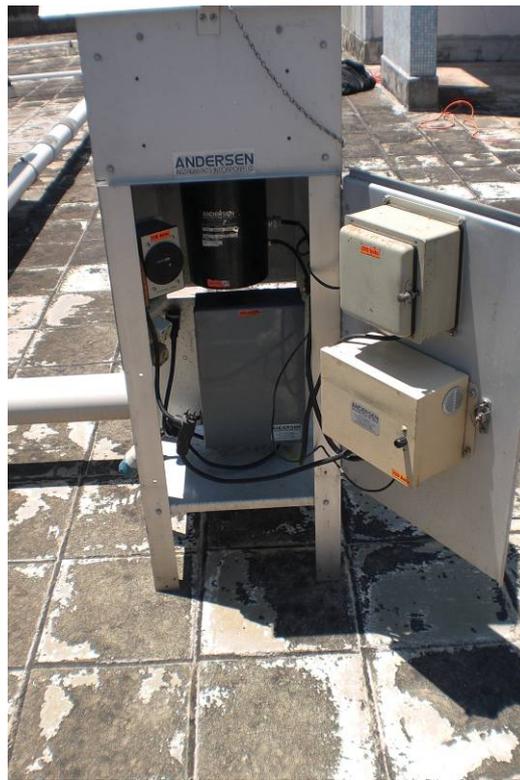
4

1-hour and 24-hour TSP air quality monitoring was conducted at the designated air quality monitoring location using a High Volume TSP Sampler (Model No: Anderson GMWS-2310 ACCU-VOL) at the designated location. The Calibration Record of the High-Volume TSP Sampler is given in Appendix B. 24-hour TSP samples were taken every six days. 1-hour TSP samples were taken three times a day between 0700-1900 hours.

Roof top of Block 15, Yuet Wu Villa

High-Volume Dust Sampler

**JOINT USER COMPLEX AND WHOLESALE FISH MARKET AT AREA 44,
TUEN MUN
PHOTOS OF AIR QUALITY MONITORING STATION**

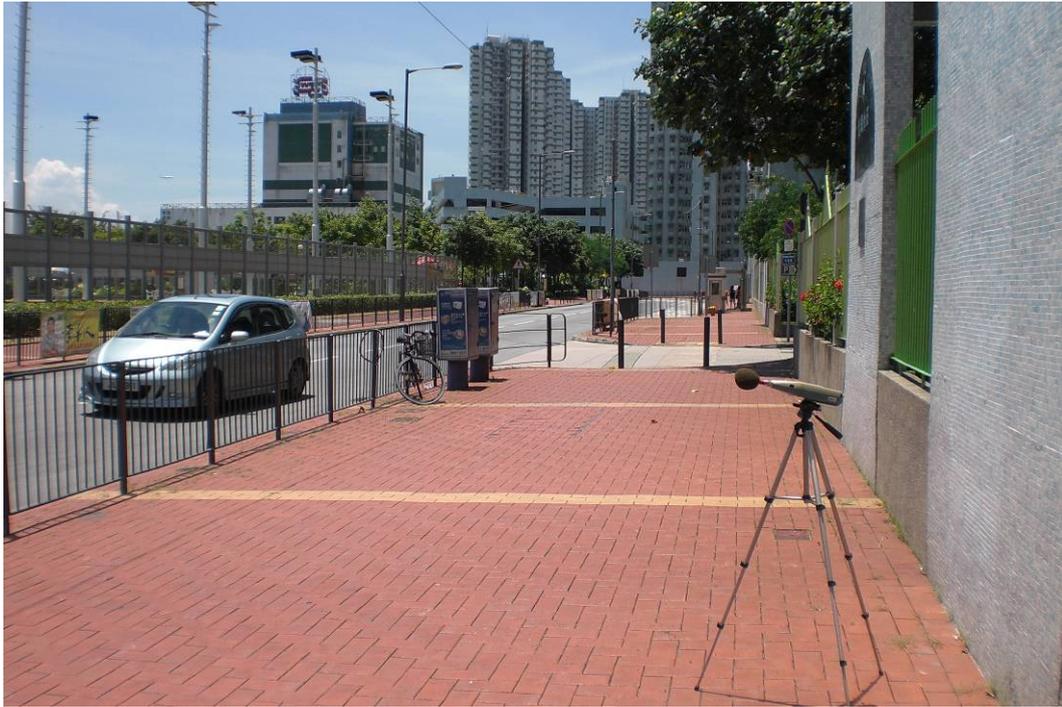
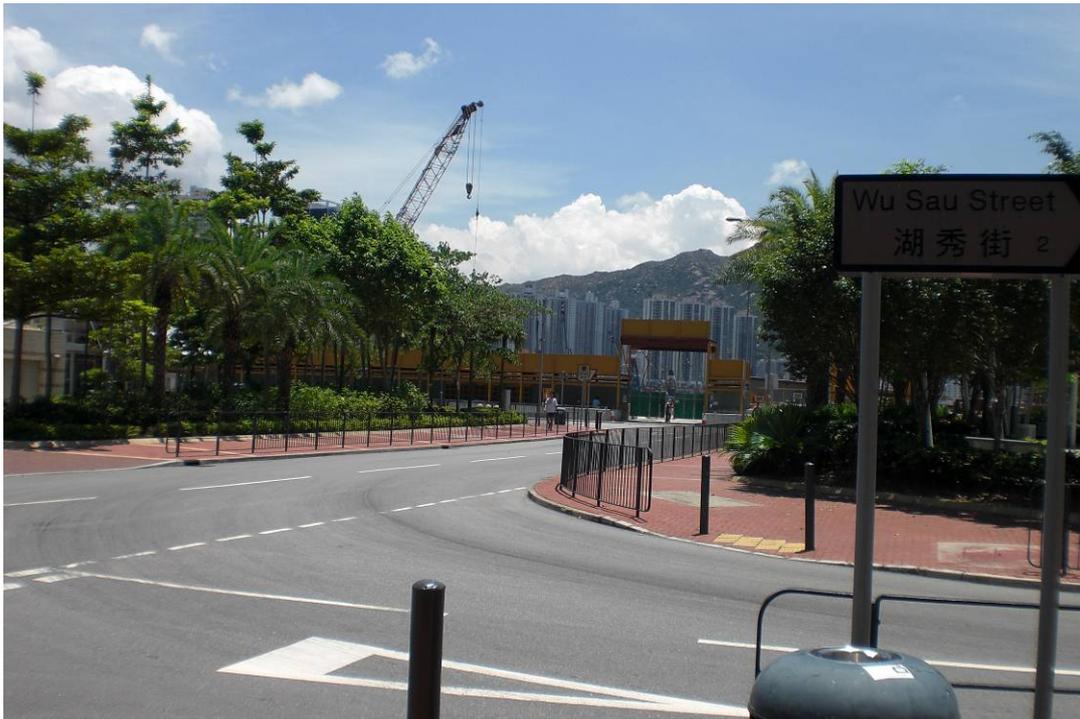
5

Noise monitoring station

View from the noise monitoring station

**JOINT USER COMPLEX AND WHOLESALE FISH MARKET AT AREA 44,
TUEN MUN
PHOTOS OF NOISE MONITORING STATION**

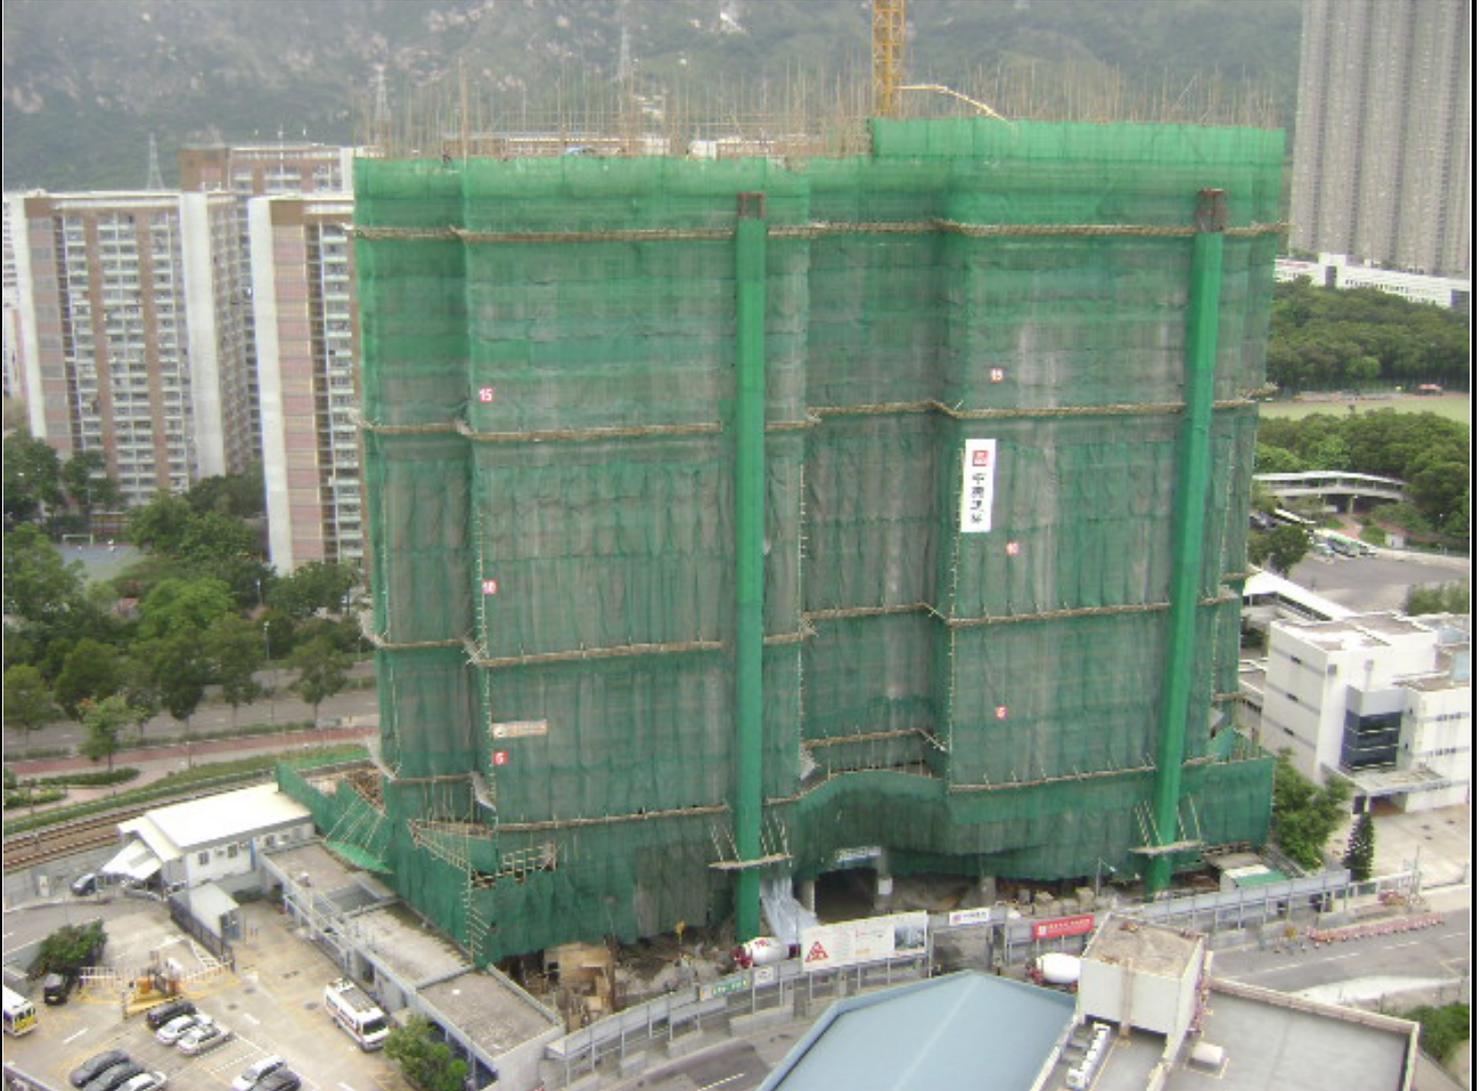
A construction site for the proposed Junior Police Officers' Married Quarters is located at Wu Hong Street which is 110m northwest from the monitoring location, which is also a potential major source of the TSP generation. Figure 6 shows the photos of the construction site.

PHOTO OF CONSTRUCTION SITE FOR JUNIOR POLICE OFFICERS' MARRIED QUARTERS

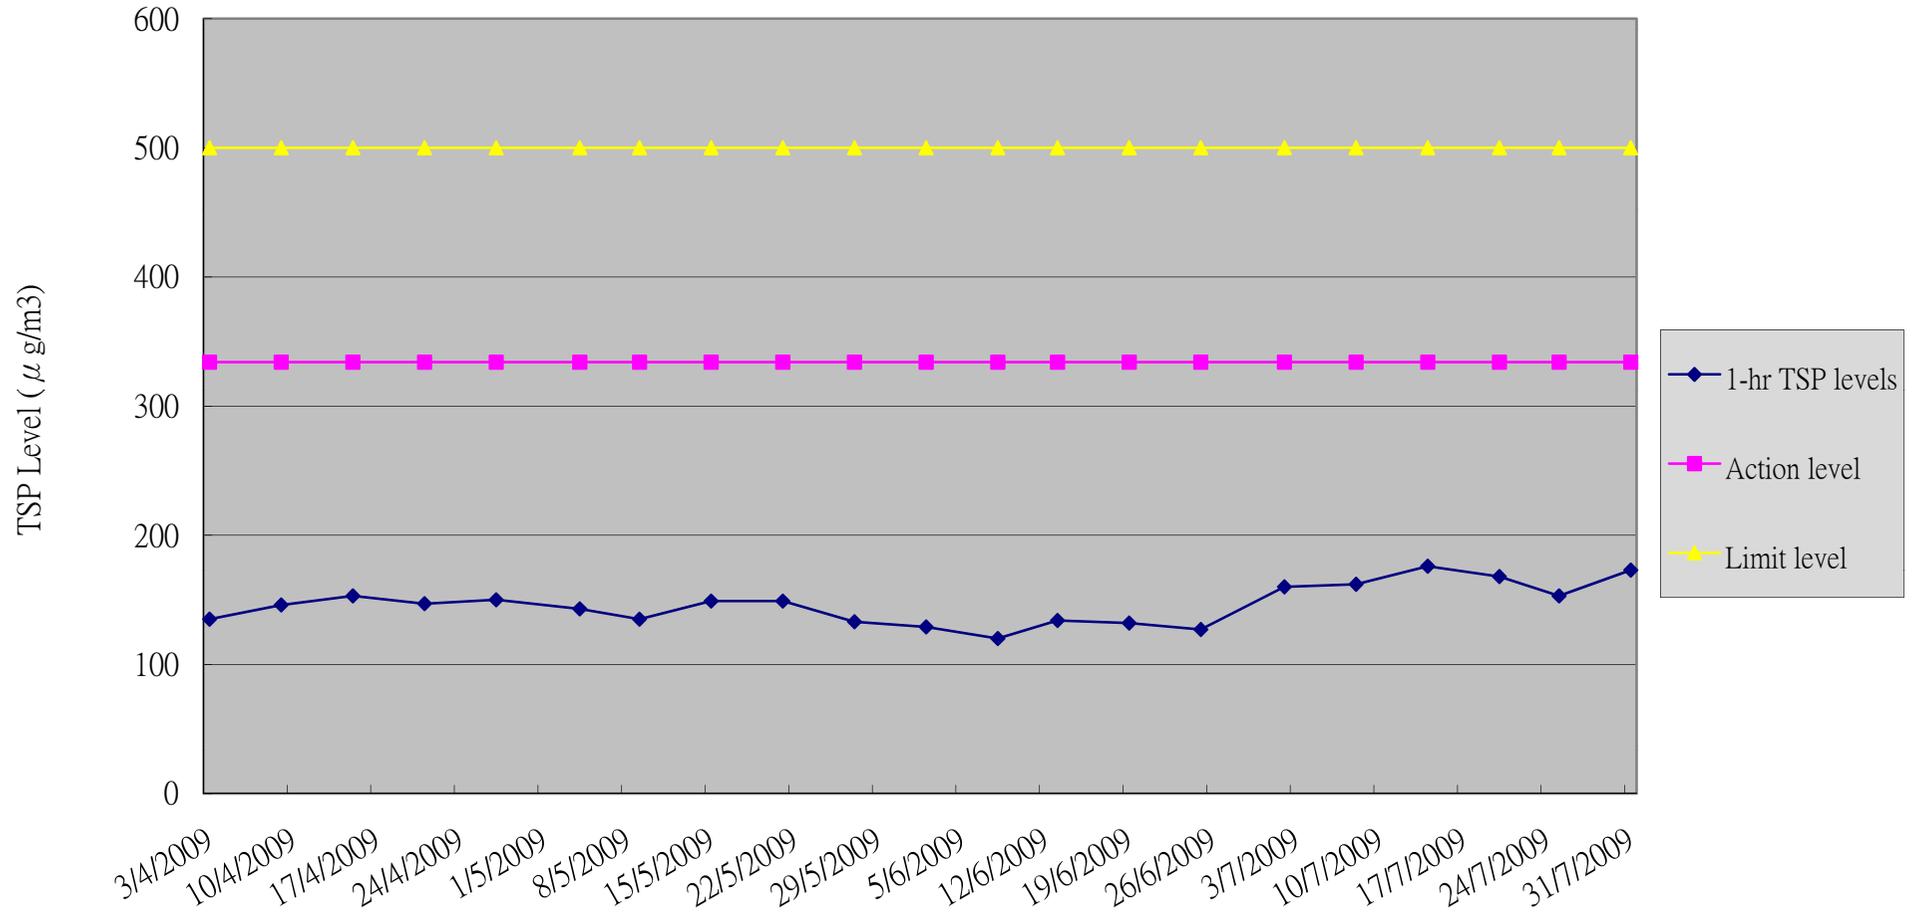
1-hr TSP Levels

No exceedance was recorded in this quarter. Summary and graphical plots of air quality monitoring record of 1-hour TSP levels and 24-hour TSP levels are provided in Appendices D and E. The weighing of the filter paper used in the monitoring will be undertaken by ASL Laboratory Group Environmental Division.

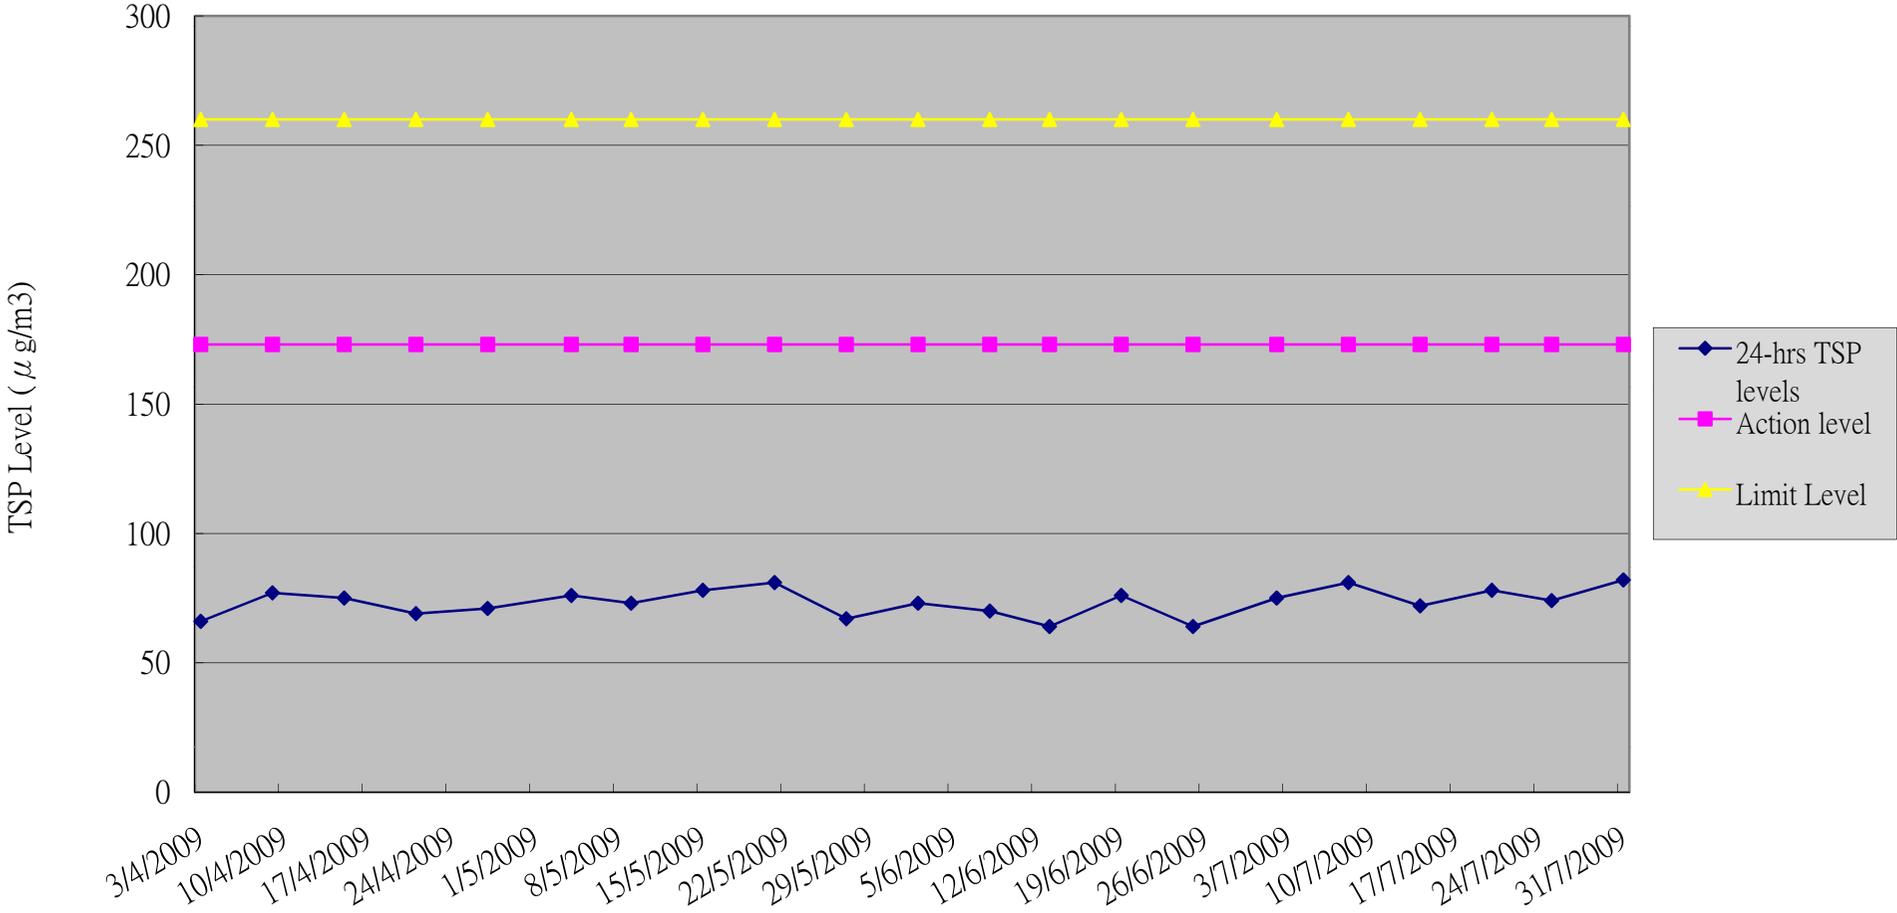
24-hour TSP Levels

Date	Start time	24-hr TSP ($\mu\text{g}/\text{m}^3$)
4-May-09	11:40	76
9-May-09	11:50	73
15-May-09	16:00	78
21-May-09	11:40	81
27-May-09	11:40	67
2-Jun-09	11:40	73
8-Jun-09	11:40	70
13-Jun-09	11:40	64
19-Jun-09	11:40	76
25-Jun-09	11:40	64
2-Jul-09	11:40	75
8-Jul-09	16:00	81
14-Jul-09	16:00	72
20-Jul-09	11:50	76
25-Jul-09	11:40	74
31-Jul-09	11:40	82

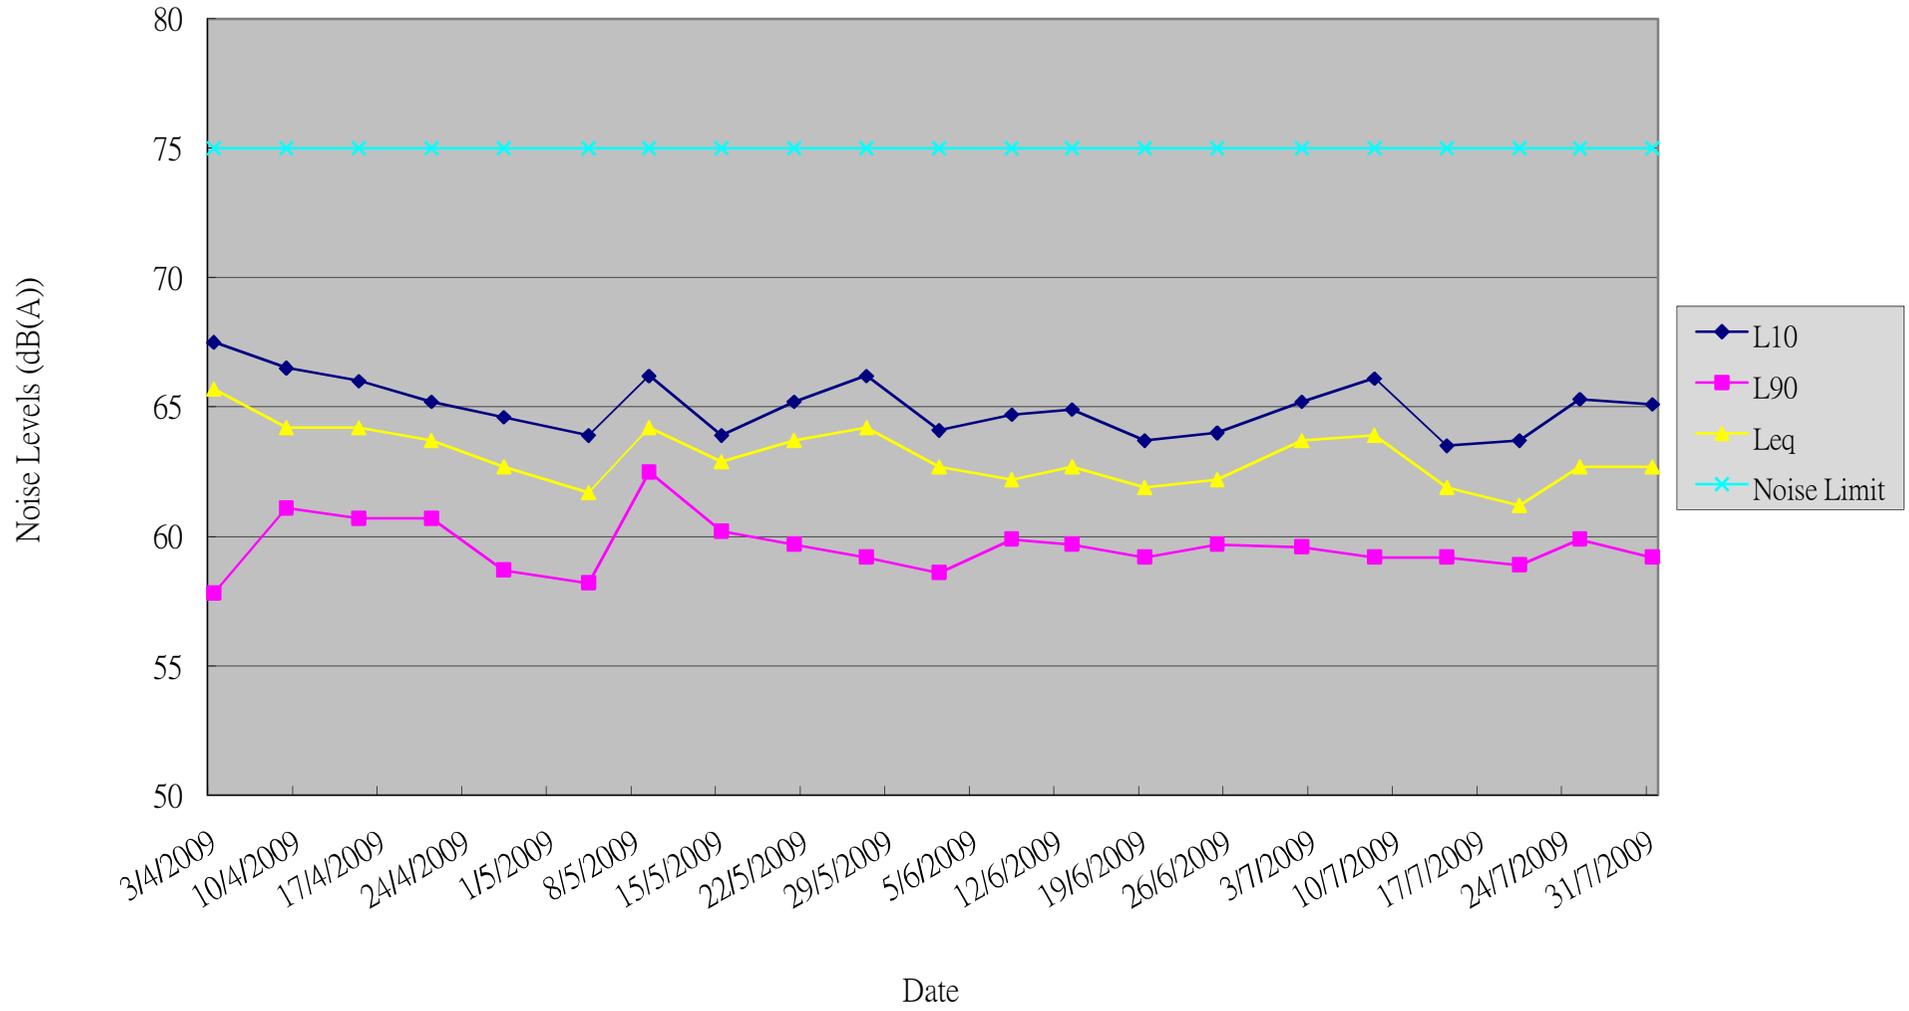
Noise Monitoring Record

No exceedance was recorded in this quarter. Summary of noise monitoring record is provided in Appendix F.

Date	Time	L10(30mins) (dB(A))	L90(30mins) (dB(A))	Leq(30mins) (dB(A))
4-May-09	09:05 - 09:35	63.9	58.2	61.7
9-May-09	09:00 - 09:30	66.2	62.5	64.2
15-May-09	13:10 - 13:40	63.9	60.2	62.9
21-May-09	09:00 - 09:30	65.2	59.7	63.7
27-May-09	09:00 - 09:30	66.2	59.2	64.2
2-Jun-09	09:00 - 09:30	64.1	58.6	62.7
8-Jun-09	09:00 - 09:30	64.7	59.9	62.2
13-Jun-09	09:00 - 09:30	64.9	59.7	62.7
19-Jun-09	09:00 - 09:30	63.7	59.2	61.9
25-Jun-09	09:02 - 09:32	64	59.7	62.2
2-Jul-09	09:00 - 09:30	65.2	59.6	63.7
8-Jul-09	13:10 - 13:40	66.1	59.2	63.9
14-Jul-09	13:10 - 13:40	63.5	59.2	61.9
20-Jul-09	09:00 - 09:30	63.7	58.9	61.2
25-Jul-09	09:00 - 09:30	65.3	59.9	62.7
31-Jul-09	09:00 - 09:30	65.1	59.2	62.7
