**JOINT USER COMPLEX AND  
WHOLESALE FISH MARKET AT  
AREA 44, TUEN MUN**

**EIGHTH QUARTERLY  
ENVIRONMENTAL MONITORING &  
AUDIT REPORT  
(MAY 2010 – JULY 2010)**

**ALLIED ENVIRONMENTAL CONSULTANTS LTD.**

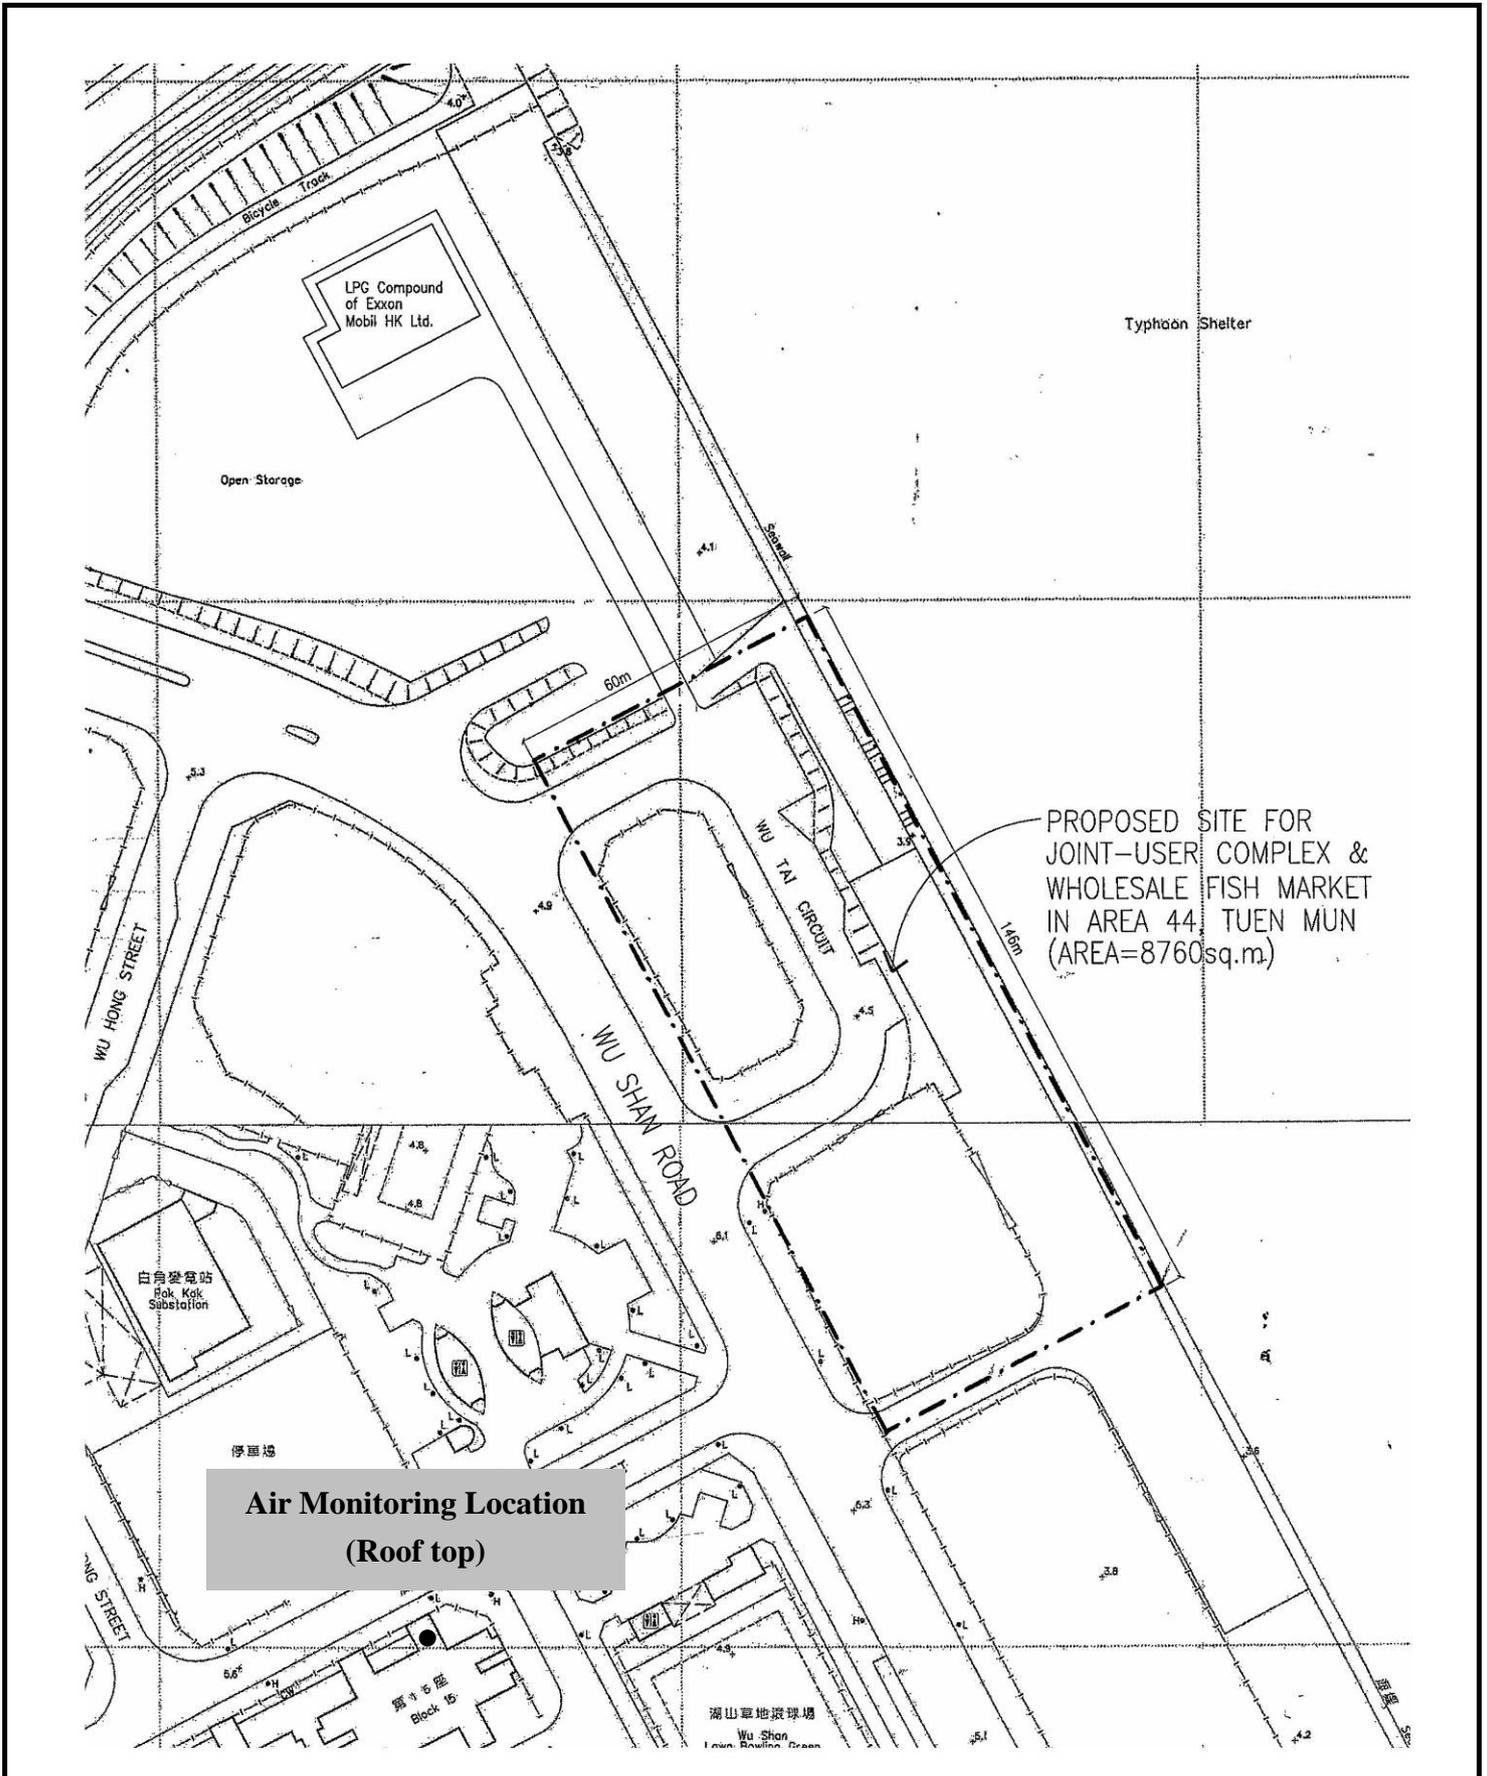
Figure No.	2	Rev.:	0
Scale	NTS	Date	8/10

1-hour and 24-hour TSP air quality monitoring was conducted at the designated air quality monitoring location using a High Volume TSP Sampler (Model No: Anderson GMWS-2310 ACCU-VOL) at the designated location. The Calibration Record of the High-Volume TSP Sampler is given in Appendix B. 24-hour TSP samples were taken every six days. 1-hour TSP samples were taken three times a day between 0700-1900 hours.

**LOCATION OF AIR QUALITY MONITORING STATION**

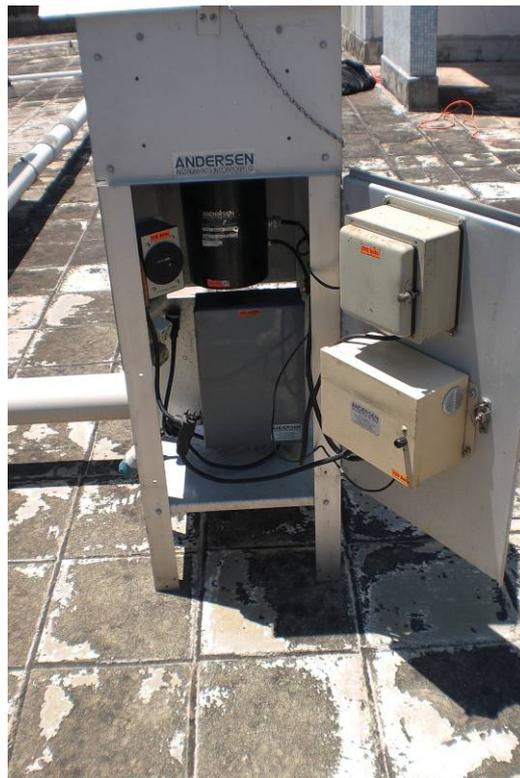
4

*Roof top of Block 15, Yuet Wu Villa*

*High-Volume Dust Sampler*

**JOINT USER COMPLEX AND WHOLESALE FISH MARKET AT AREA 44,  
TUEN MUN  
PHOTOS OF AIR QUALITY MONITORING STATION**

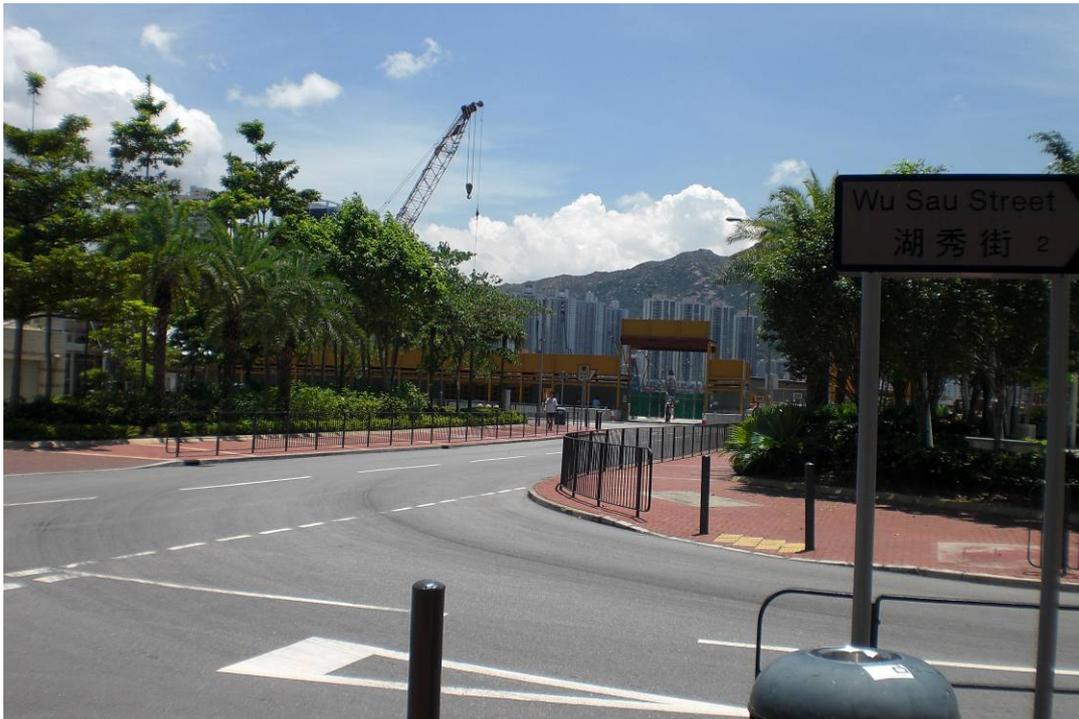
5

*Noise monitoring station*

*View from the noise monitoring station*

**JOINT USER COMPLEX AND WHOLESALE FISH MARKET AT AREA 44,  
TUEN MUN  
PHOTOS OF NOISE MONITORING STATION**

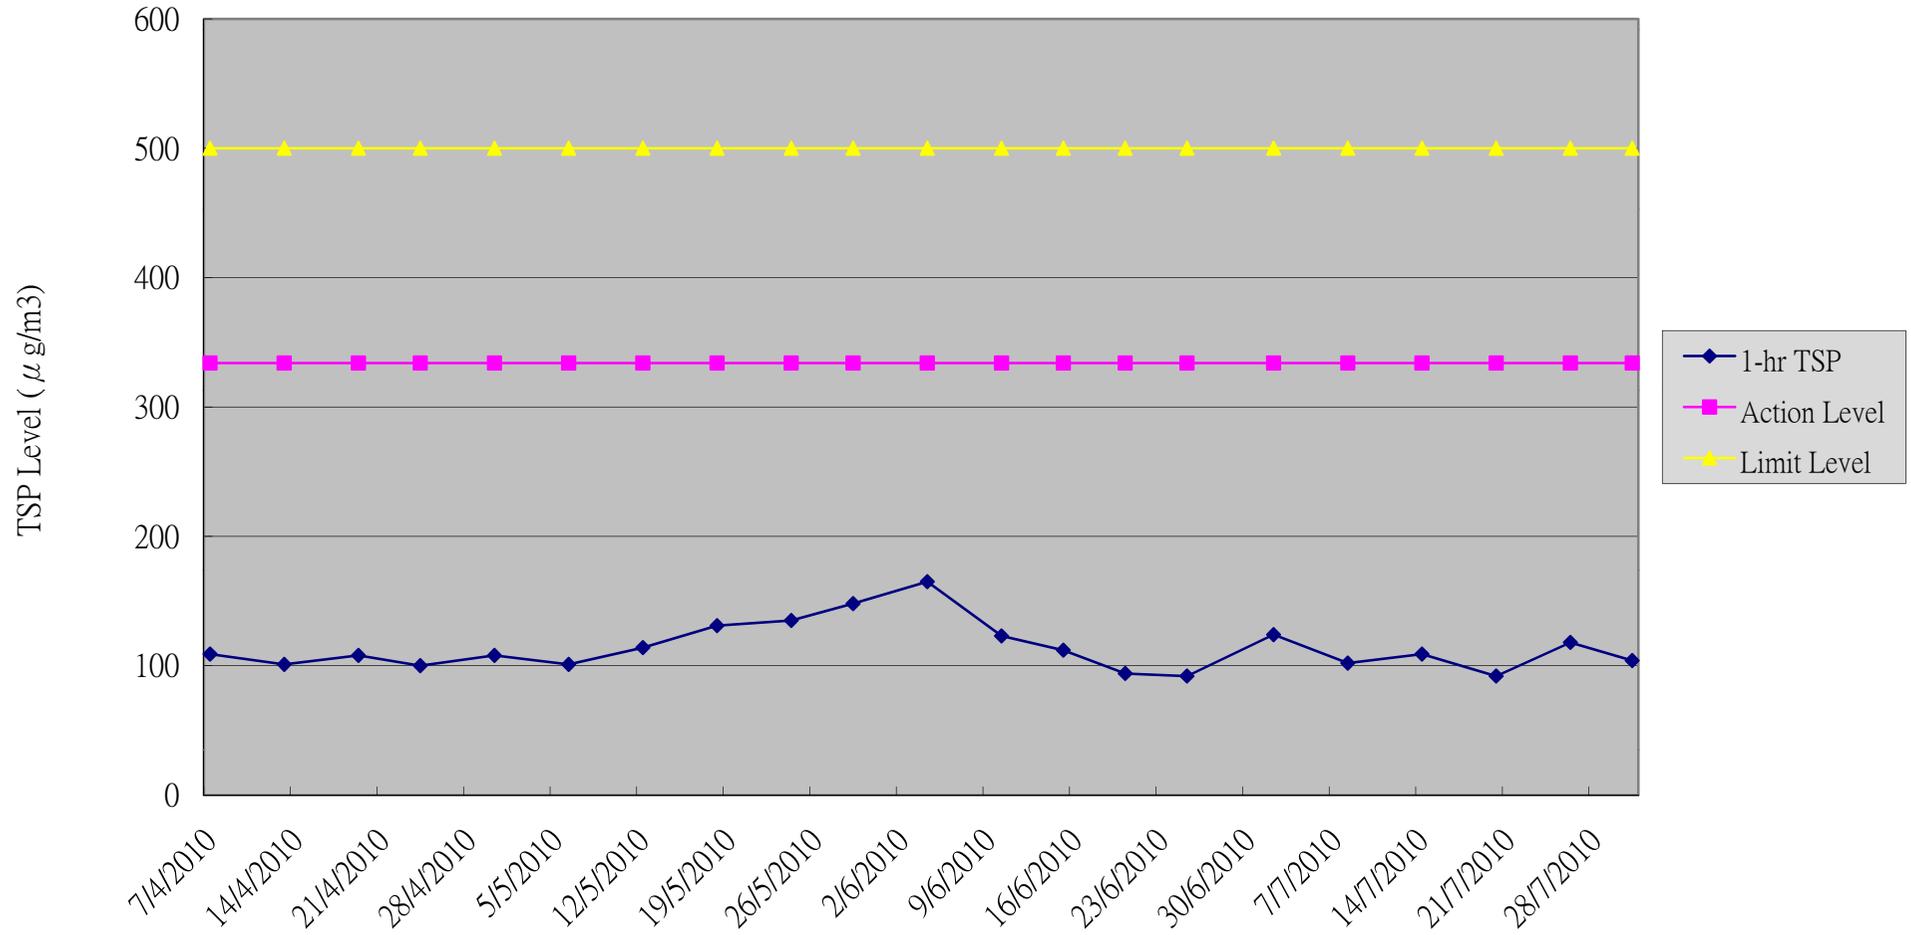
1-hr TSP Levels (Quarter: May2010 - July 2010)

No exceedance was recorded in this quarter. Summary and graphical plots of air quality monitoring record of 1-hour TSP levels and 24-hour TSP levels are provided in Appendices D and E. The weighing of the filter paper used in the monitoring will be undertaken by ALS Laboratory Group Environmental Division. (HOKLAS Registration No.: 066)

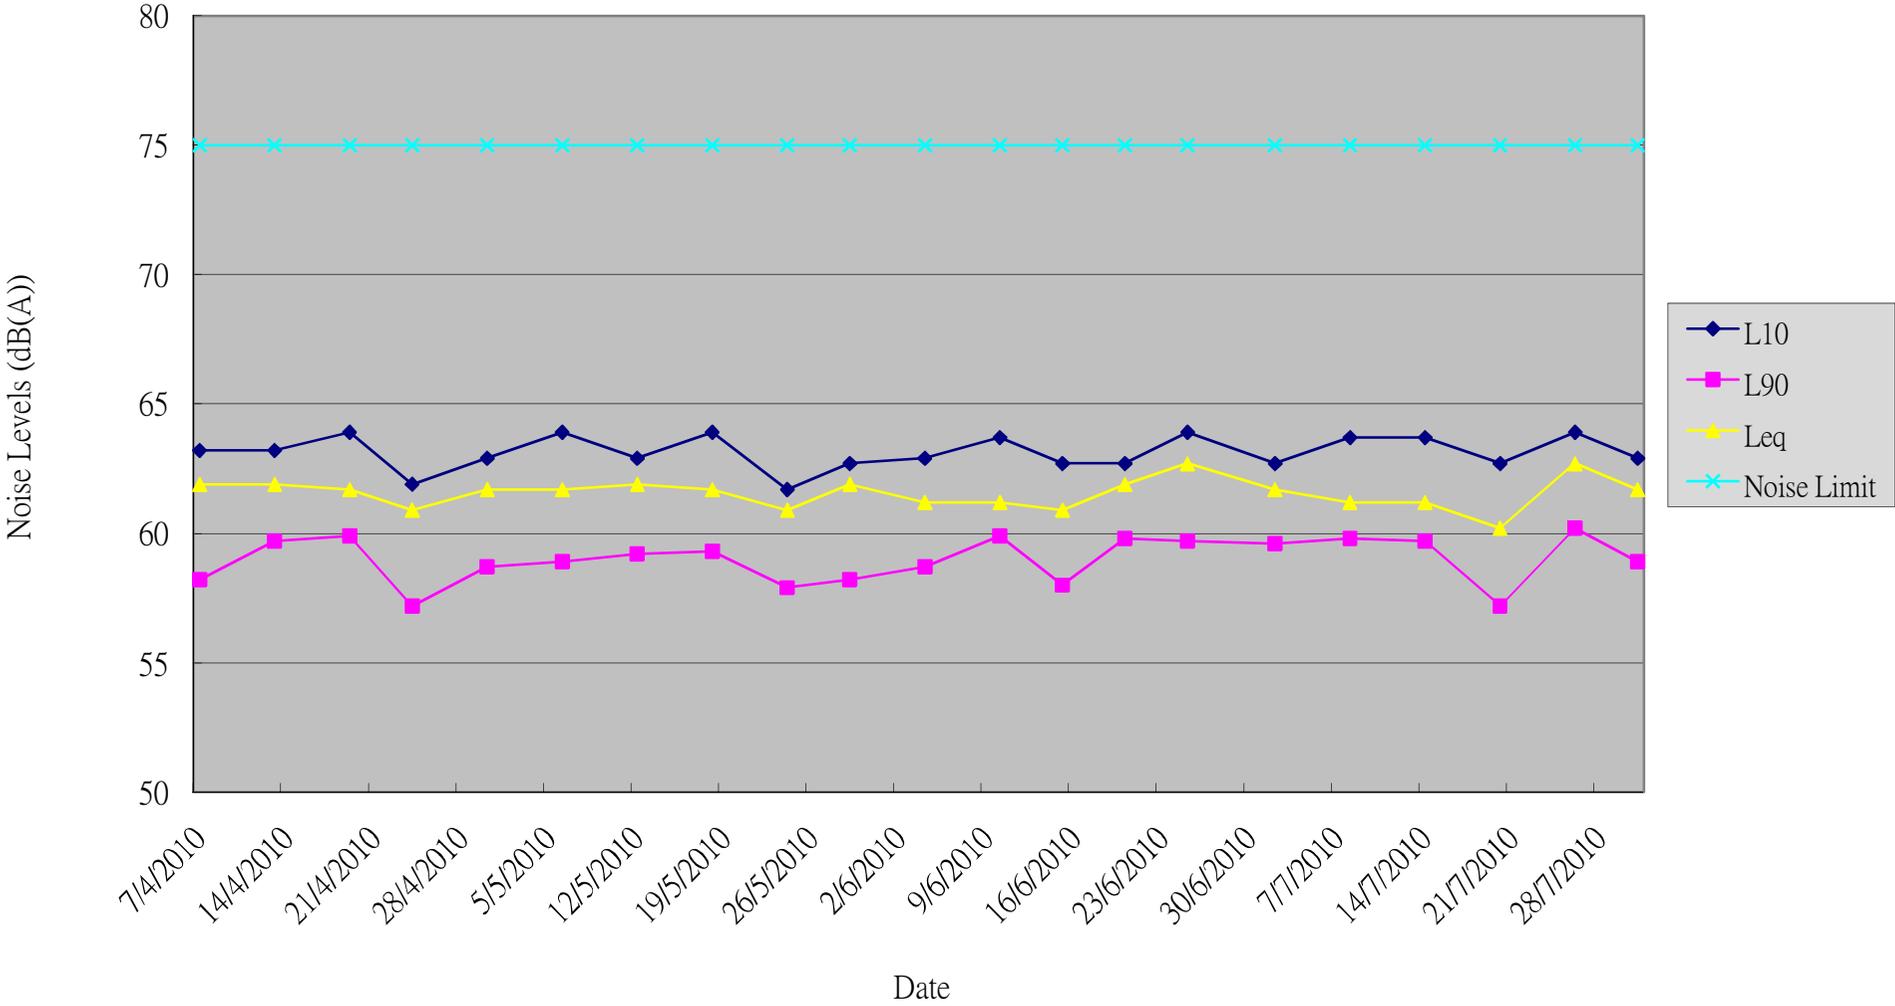
Noise Monitoring Record (Quarter: May 2010- July2010)

Noise monitoring results in terms of  $L_{eq(30min)}$ ,  $L_{10(30min)}$   $L_{90(30min)}$  were measured at the designated noise monitoring location.  $L_{10}$  and  $L_{90}$  represent sound levels that are exceeded 10% and 90% of the time respectively. Normally,  $L_{10}$  measurements can be considered as the average peak levels, whilst  $L_{90}$  levels can be considered as the average background noise levels.

No exceedance was recorded in this quarter. Summary of noise monitoring record is provided in Appendix F.
