**JOINT USER COMPLEX AND  
WHOLESALE FISH MARKET AT  
AREA 44, TUEN MUN**

**ENVIRONMENTAL MONITORING &  
AUDIT REPORT (OCTOBER 2010)**

**ALLIED ENVIRONMENTAL CONSULTANTS LTD.**

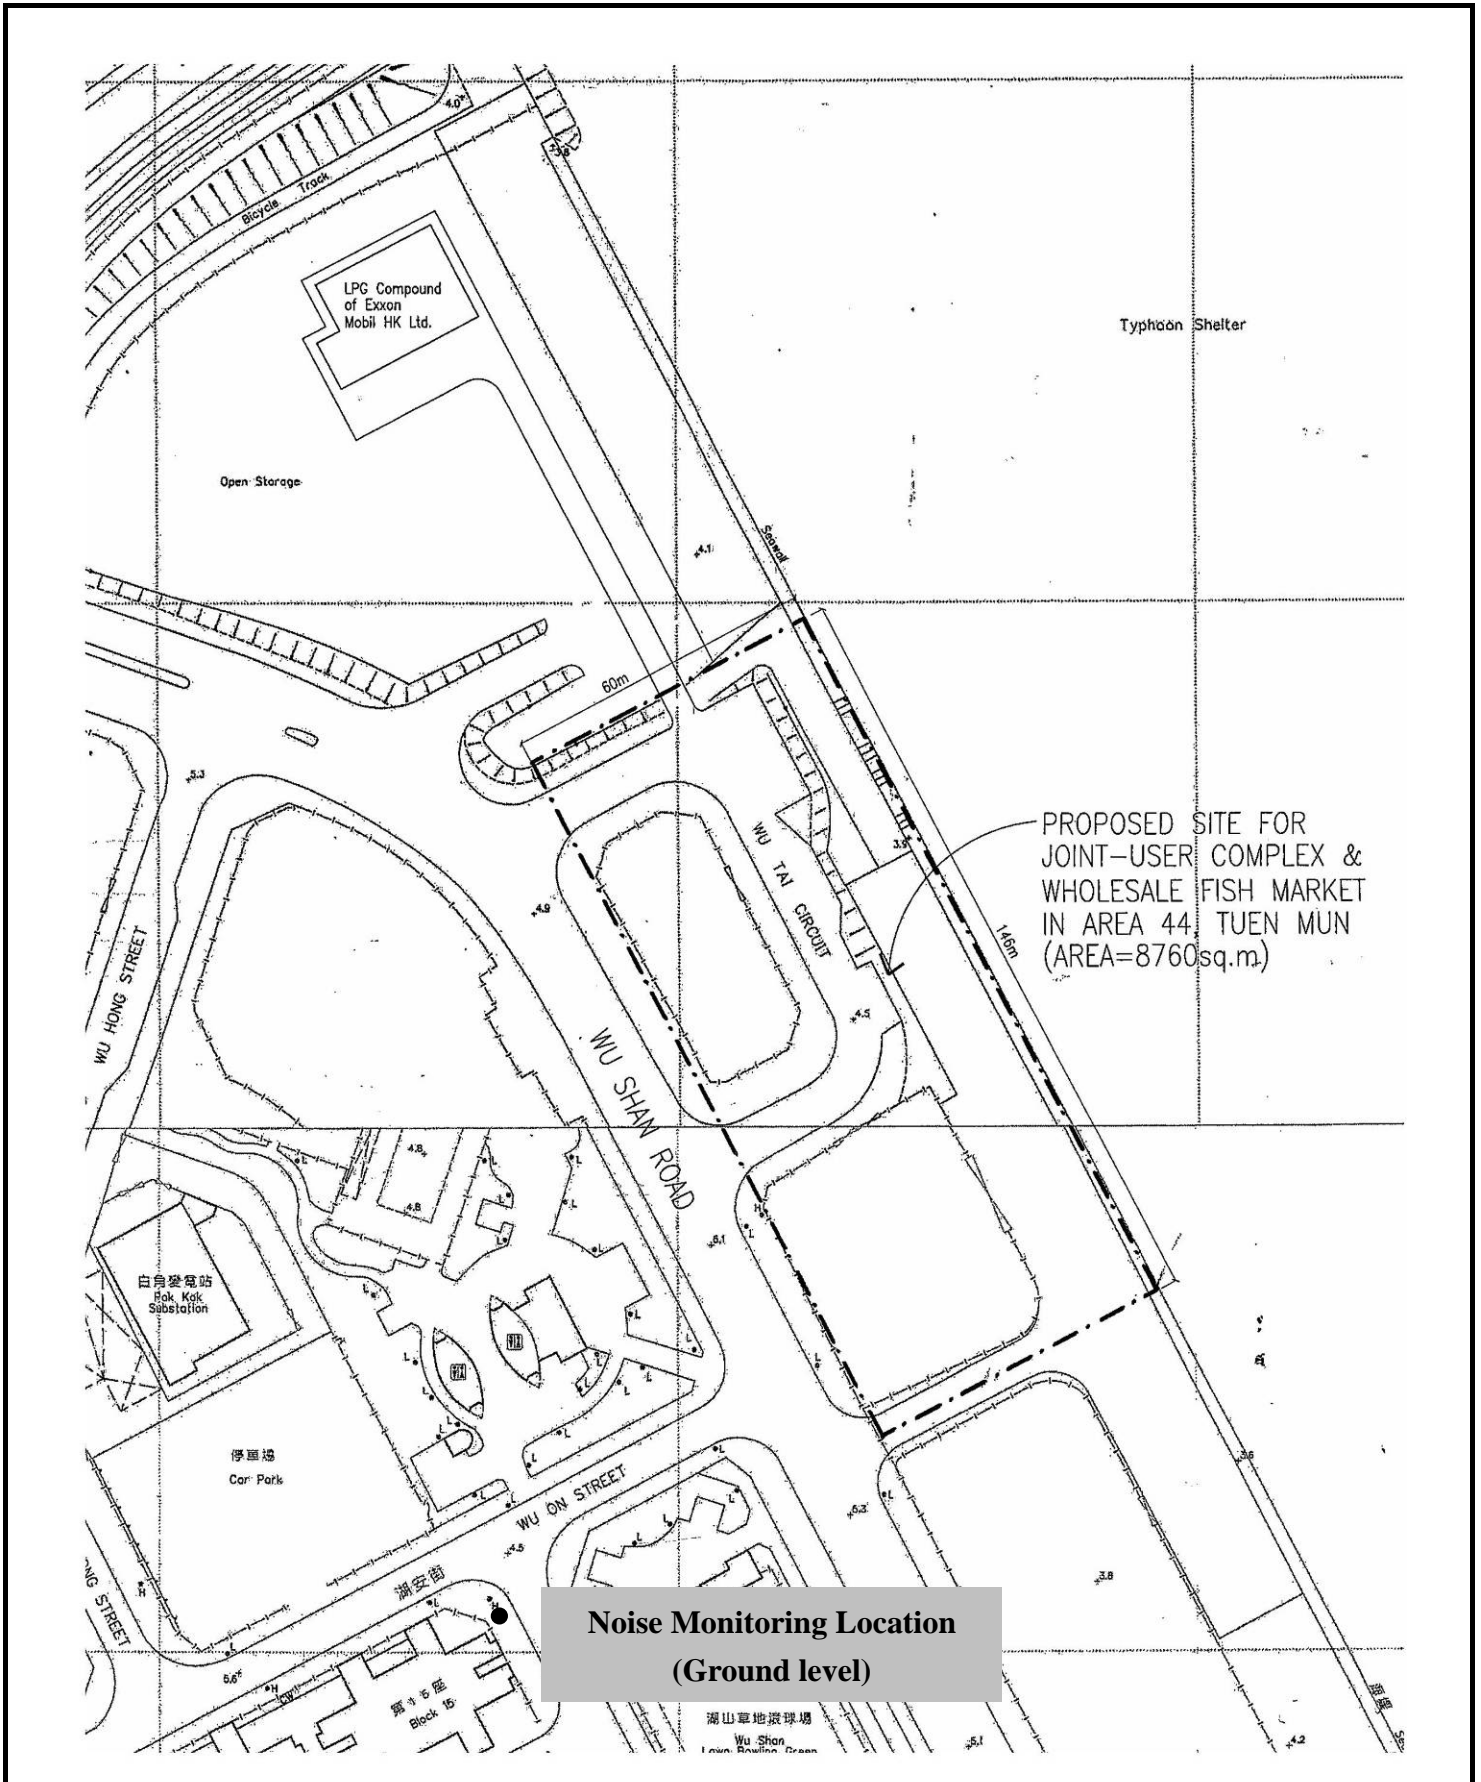
Figure No.	3	Rev.:	0
Scale	NTS	Date	11/10

**Noise Monitoring Location  
(Ground level)**

**JOINT USER COMPLEX AND WHOLESALE FISH MARKET AT AREA 44,  
TUEN MUN  
LOCATION OF NOISE MONITORING STATION**

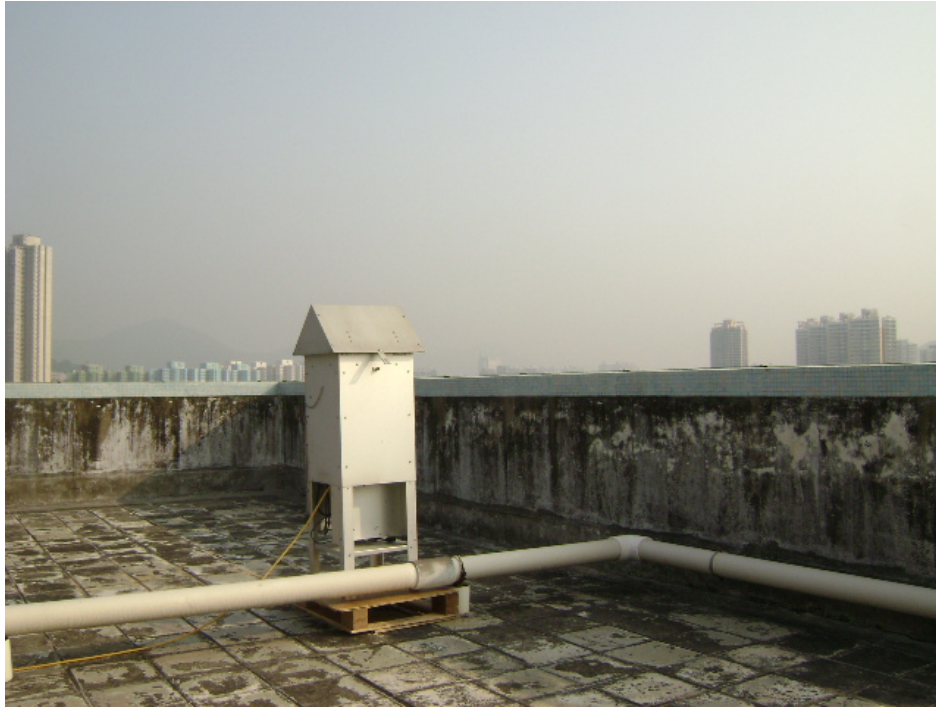
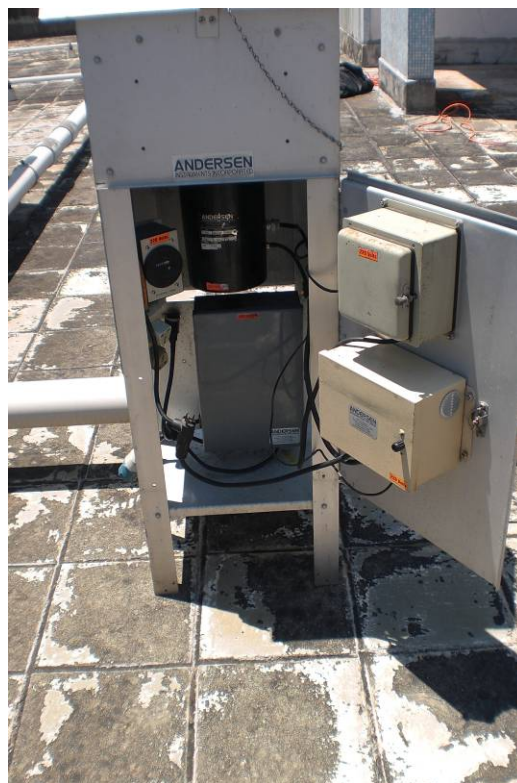
4

*Roof top of Block 15, Yuet Wu Villa*

*High-Volume Dust Sampler*

**JOINT USER COMPLEX AND WHOLESALE FISH MARKET AT AREA 44,  
TUEN MUN  
PHOTOS OF AIR QUALITY MONITORING STATION**

1-hour and 24-hour TSP air quality monitoring was conducted at the designated air quality monitoring location using a High Volume TSP Sampler (Model No: Anderson GMWS-2310 ACCU-VOL) at the designated location. The Calibration Record of the High-Volume TSP Sampler is given in Appendix B. 24-hour TSP samples were taken every six days. 1-hour TSP samples were taken three times a day between 0700-1900 hours. The weighing of the filter paper used in the monitoring was undertaken by ALS Laboratory Group Environmental Division. (HOKLAS Registration No.: 066)

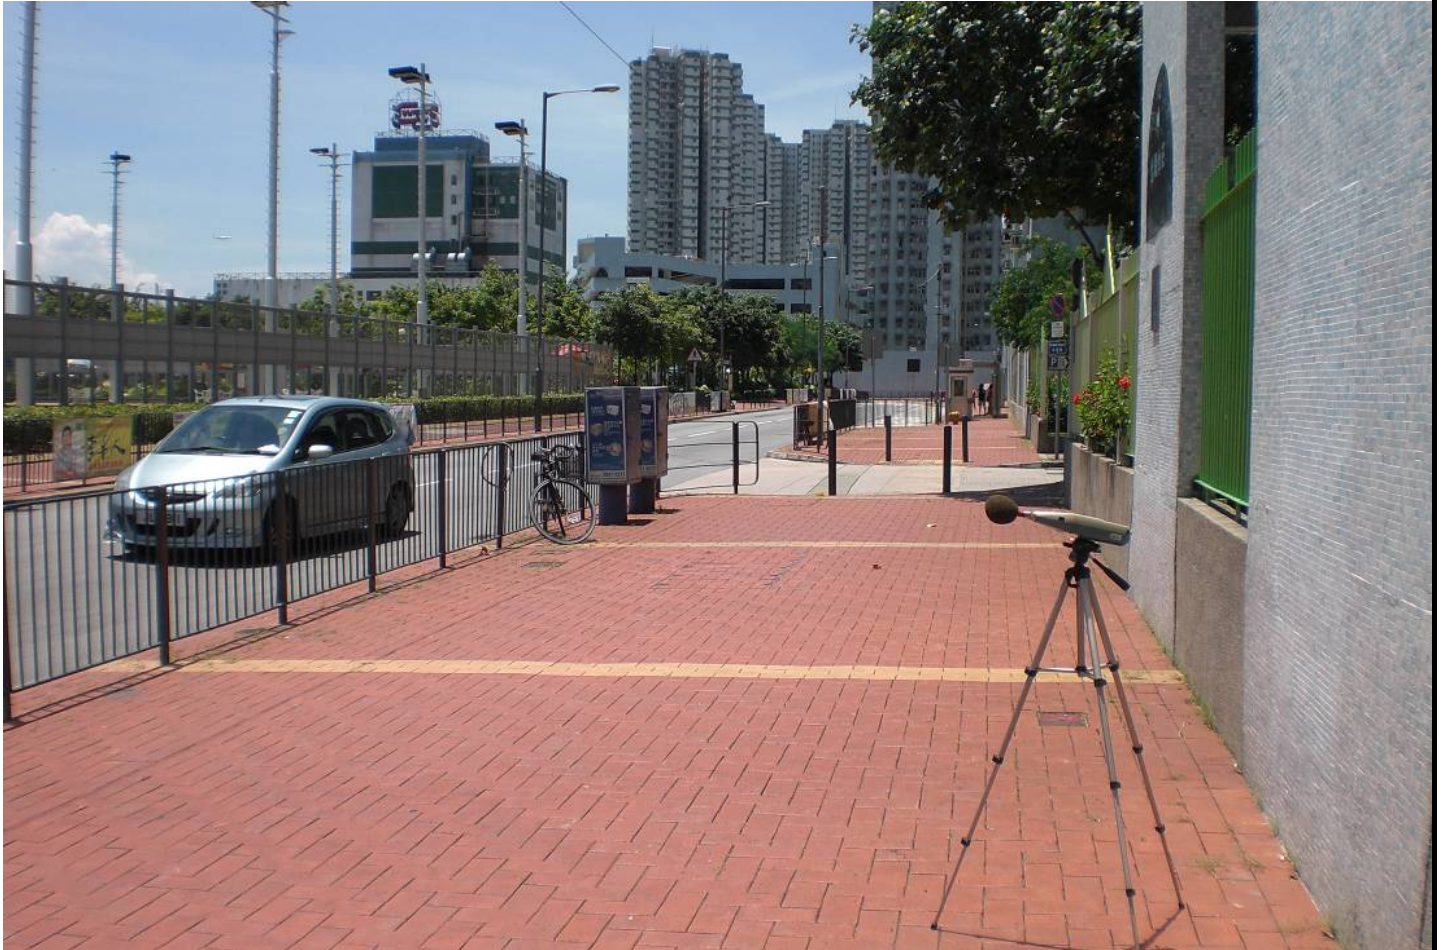
5

**JOINT USER COMPLEX AND WHOLESALE FISH MARKET AT AREA 44,  
TUEN MUN  
PHOTOS OF NOISE MONITORING STATION**

Noise level measurements were recorded in terms of thirty minutes A-weighted equivalent continuous sound pressure level ( $L_{eq(30min)}$ ) on a daily basis. The sound level meter was calibrated immediately prior to and following each noise measurement. The meter was mounted on a tripod at a height of 1.2m and the microphone was positioned at 1m away the building façade of the noise monitoring station facing the construction site.
