**JOINT USER COMPLEX AND  
WHOLESALE FISH MARKET AT  
AREA 44, TUEN MUN**

**ENVIRONMENTAL MONITORING &  
AUDIT REPORT (NOVEMBER 2010)**

**ALLIED ENVIRONMENTAL CONSULTANTS LTD.**

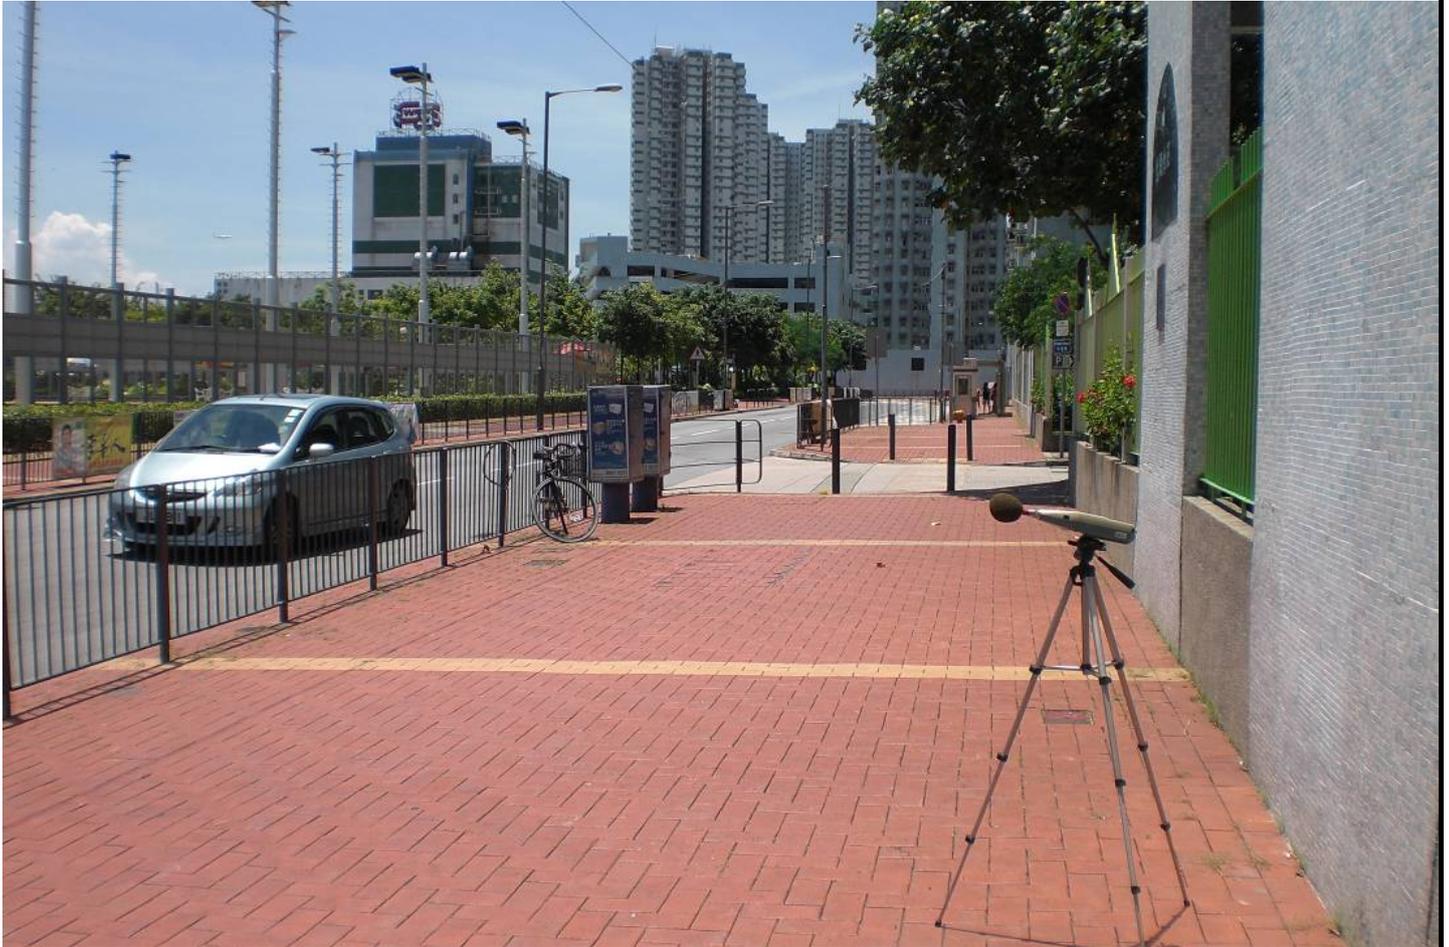
5

**JOINT USER COMPLEX AND WHOLESALE FISH MARKET AT AREA 44,  
TUEN MUN  
PHOTOS OF NOISE MONITORING STATION**
