**JOINT USER COMPLEX AND
WHOLESALE FISH MARKET AT
AREA 44, TUEN MUN**

**ENVIRONMENTAL MONITORING &
AUDIT REPORT (NOVEMBER 2009)**

ALLIED ENVIRONMENTAL CONSULTANTS LTD.

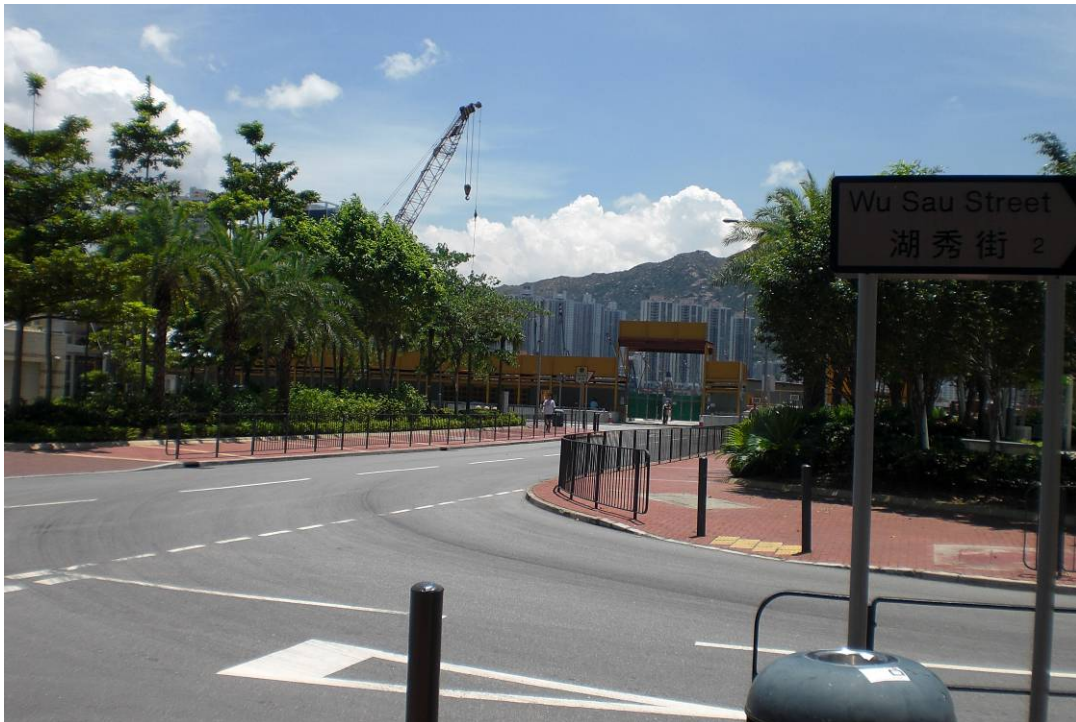
5

on a tripod at a height of 1.2m and the microphone was positioned at 1m away the building façade of the noise monitoring station facing the construction site.

Noise monitoring station

View from the noise monitoring station

**JOINT USER COMPLEX AND WHOLESALE FISH MARKET AT AREA 44,
TUEN MUN
PHOTOS OF NOISE MONITORING STATION**

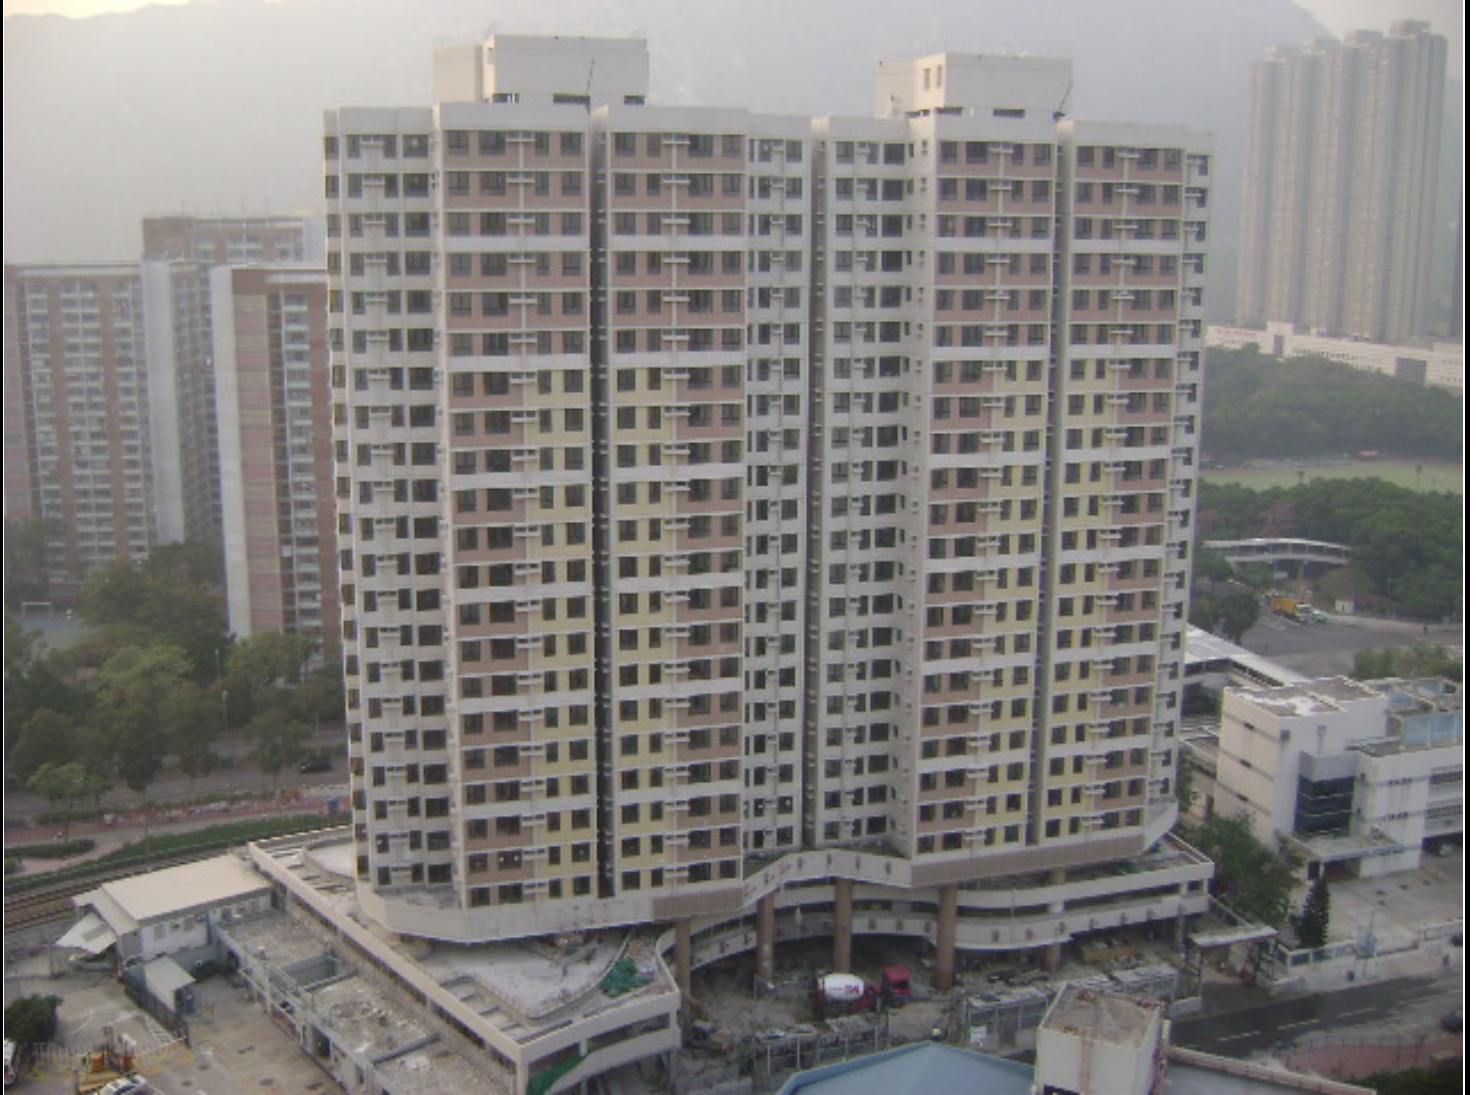
A construction site for the proposed Junior Police Officers' Married Quarters is located at Wu Hong Street which is 110m away from the monitoring location, which can be a major source of the noise and TSP generation during the monitoring period. Figure 6 shows the photo of the construction site.

PHOTO OF CONSTRUCTION SITE FOR JUNIOR POLICE OFFICERS' MARRIED QUARTERS

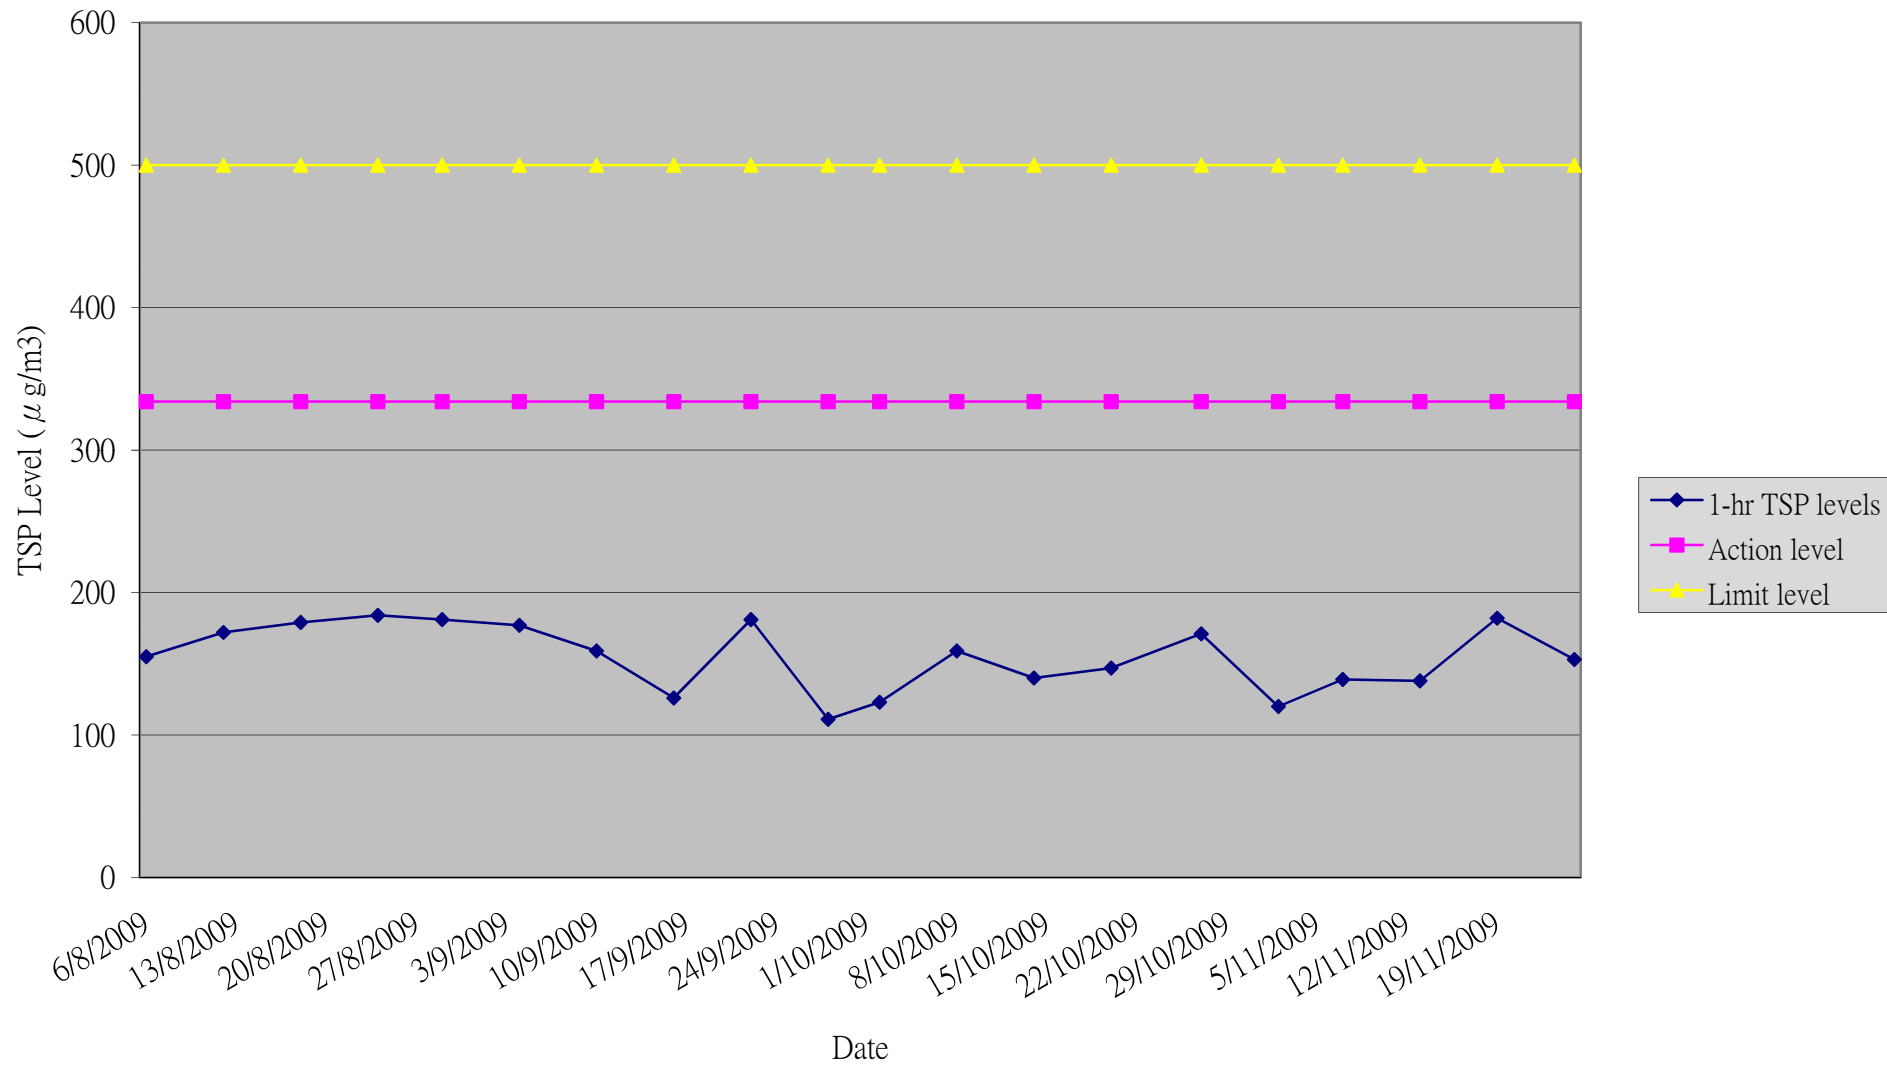
1-hr TSP Levels

1-hour and 24-hour TSP monitoring results are summarized in Table 7 and 8 and serve as the basis for determining the action and limit levels. The minimum and maximum 1-hour TSP measured at Yuet Wu Villa was $107\mu\text{g}/\text{m}^3$ and $193\mu\text{g}/\text{m}^3$ respectively with an average of $146\mu\text{g}/\text{m}^3$. The minimum and maximum 24-hour TSP measured was $68\mu\text{g}/\text{m}^3$ and $87\mu\text{g}/\text{m}^3$ respectively with an average of $76\mu\text{g}/\text{m}^3$. Summary of air quality monitoring record is provided in Appendix D and E.

Date	Time	1-hr TSP ($\mu\text{g}/\text{m}^3$)	Average
2-Nov-09	13:00 - 14:00	125	120
	14:00 - 15:00	124	
	15:00 - 16:00	112	
7-Nov-09	08:50 - 09:50	157	139
	09:50 - 10:50	152	
	10:50 - 11:50	107	
13-Nov-09	13:00 - 14:00	113	138
	14:00 - 15:00	149	
	15:00 - 16:00	151	
19-Nov-09	13:00 - 14:00	169	182
	14:00 - 15:00	193	
	15:00 - 16:00	183	
25-Nov-09	13:00 - 14:00	122	153
	14:00 - 15:00	167	
	15:00 - 16:00	169	
		Average	146
