**JOINT USER COMPLEX AND  
WHOLESALE FISH MARKET AT  
AREA 44, TUEN MUN**

**ENVIRONMENTAL MONITORING &  
AUDIT REPORT (SEPTEMBER 2010)**

**ALLIED ENVIRONMENTAL CONSULTANTS LTD.**

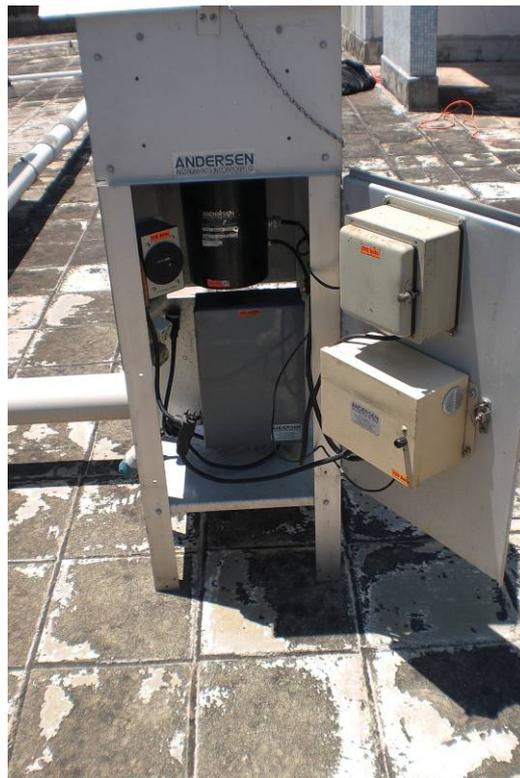
Figure No.

*Roof top of Block 15, Yuet Wu Villa*

*High-Volume Dust Sampler*

**JOINT USER COMPLEX AND WHOLESALE FISH MARKET AT AREA 44,  
TUEN MUN  
PHOTOS OF AIR QUALITY MONITORING STATION**
